Mooring Modifications for the Reduction of Losses to Vandalism

Technical and Scientific Workshop

Data Buoy Cooperation Panel

Mooring Vandalism

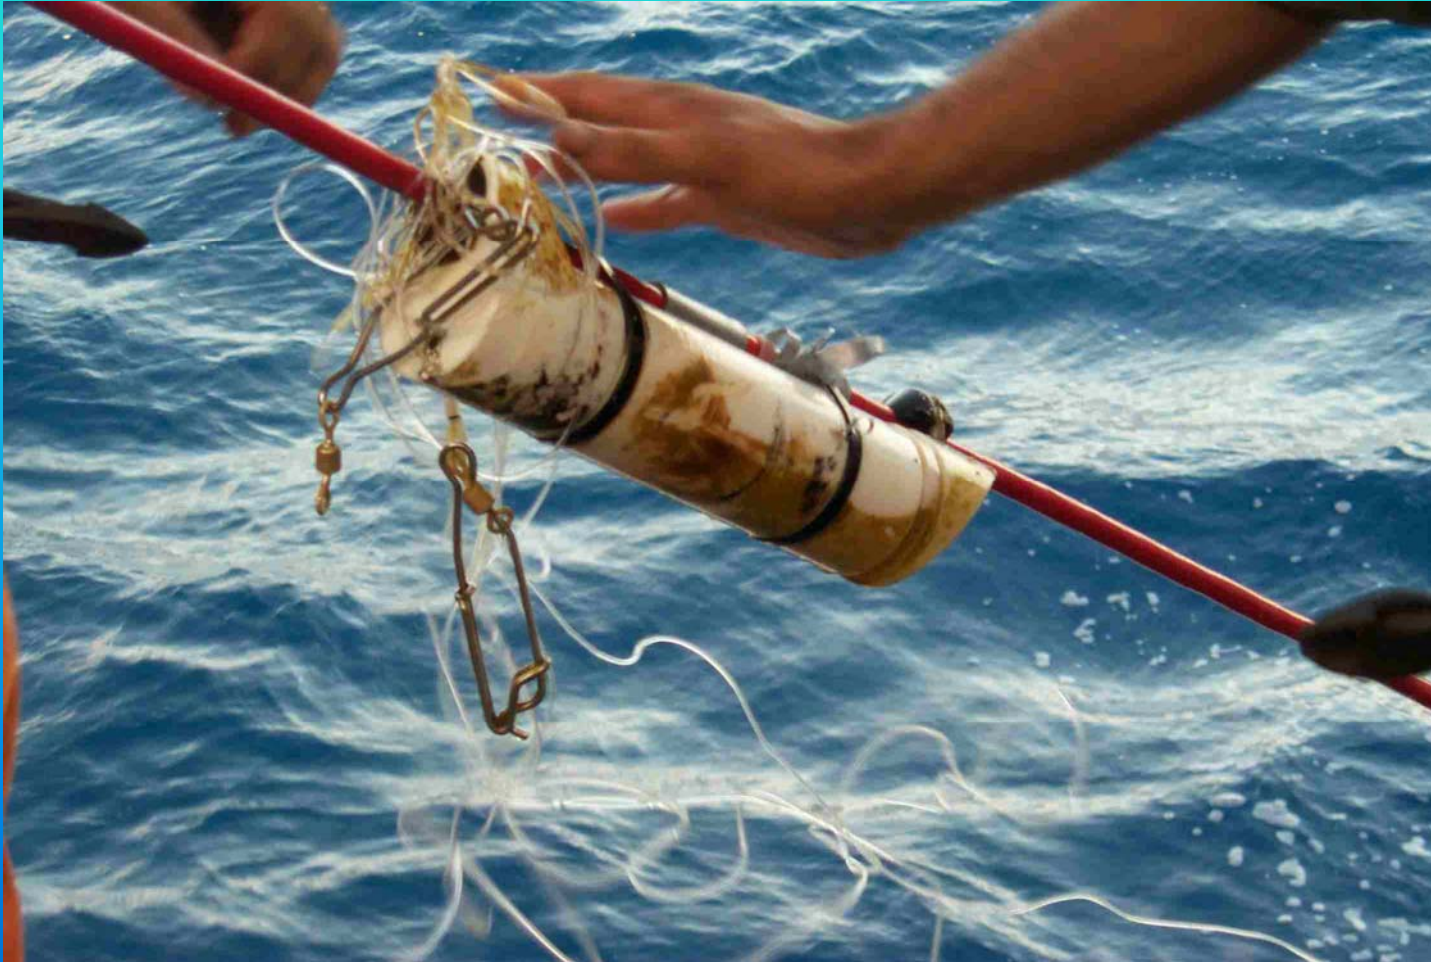
Minor fouling of temperature sensor by longline. No impact on data.
Can be hazardous to personnel.

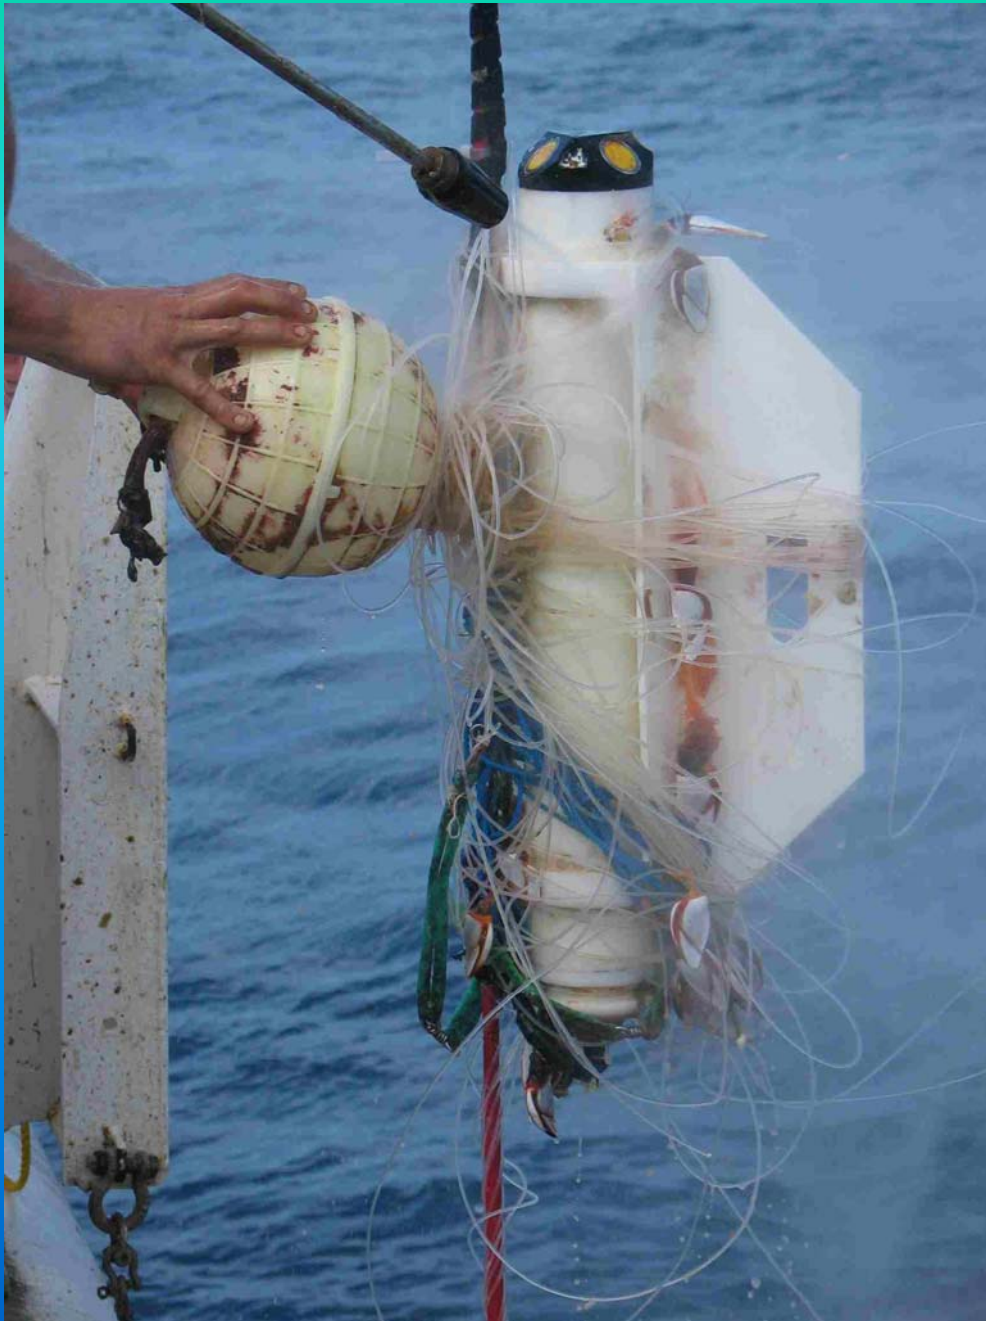
- Fouling of Doppler Current Meter with longline and float
- Potential impact on data quality.
- Damage to connector and electrical cable.

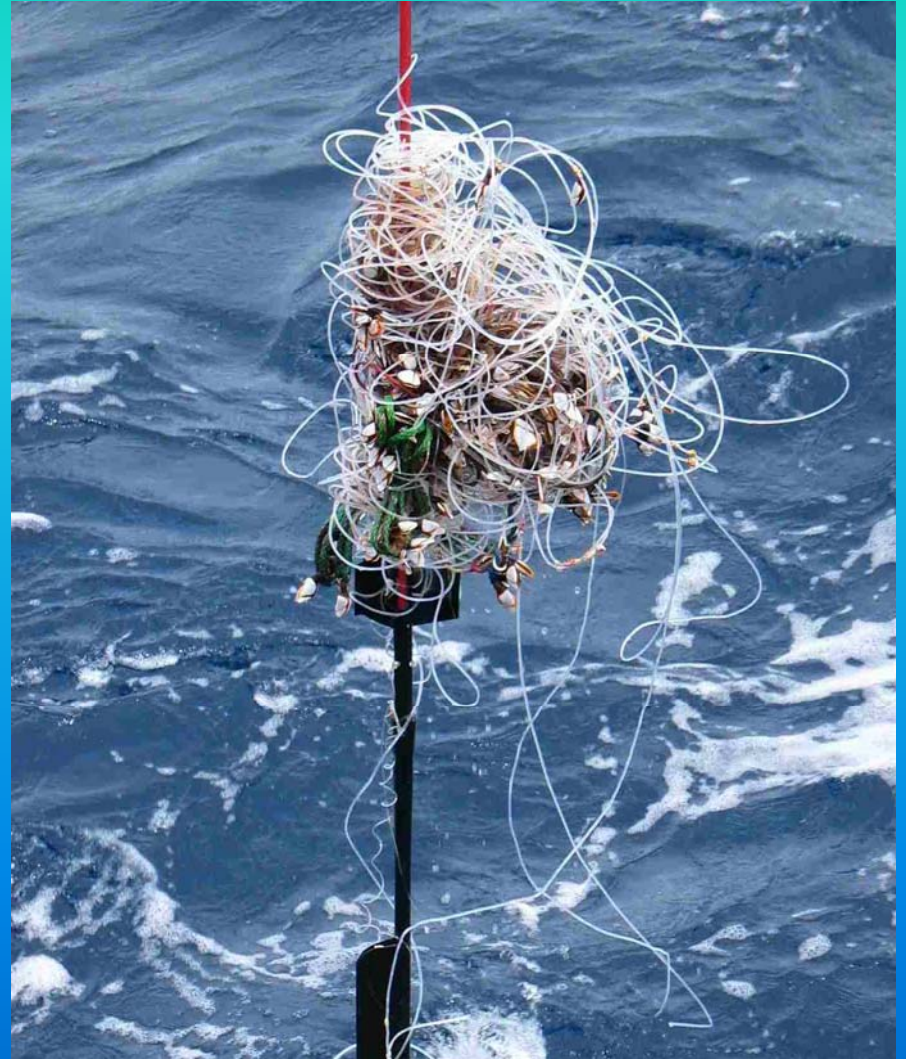
Longline completely engulfs instrument.

Cuts to wire jacket can cause failure of data telemetry.

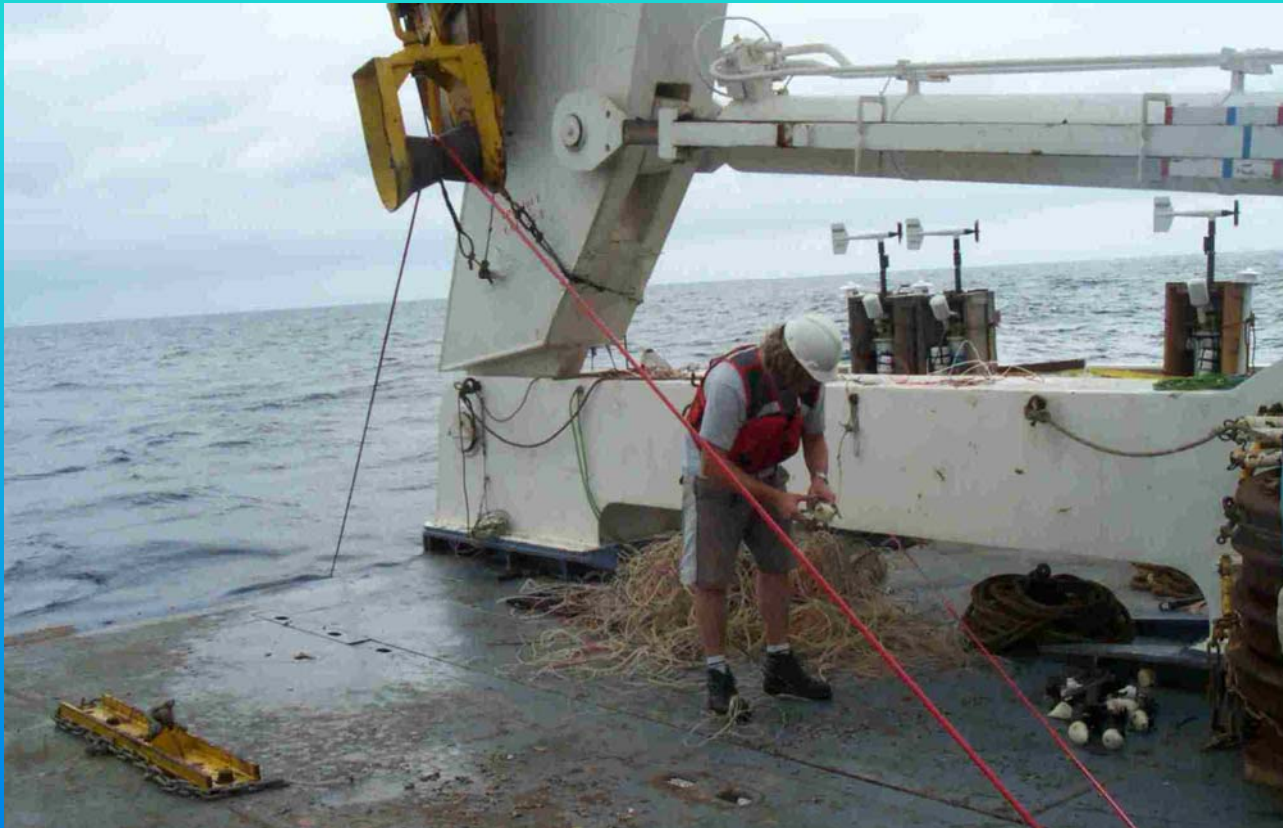
Large amounts of longline can increase drag on mooring

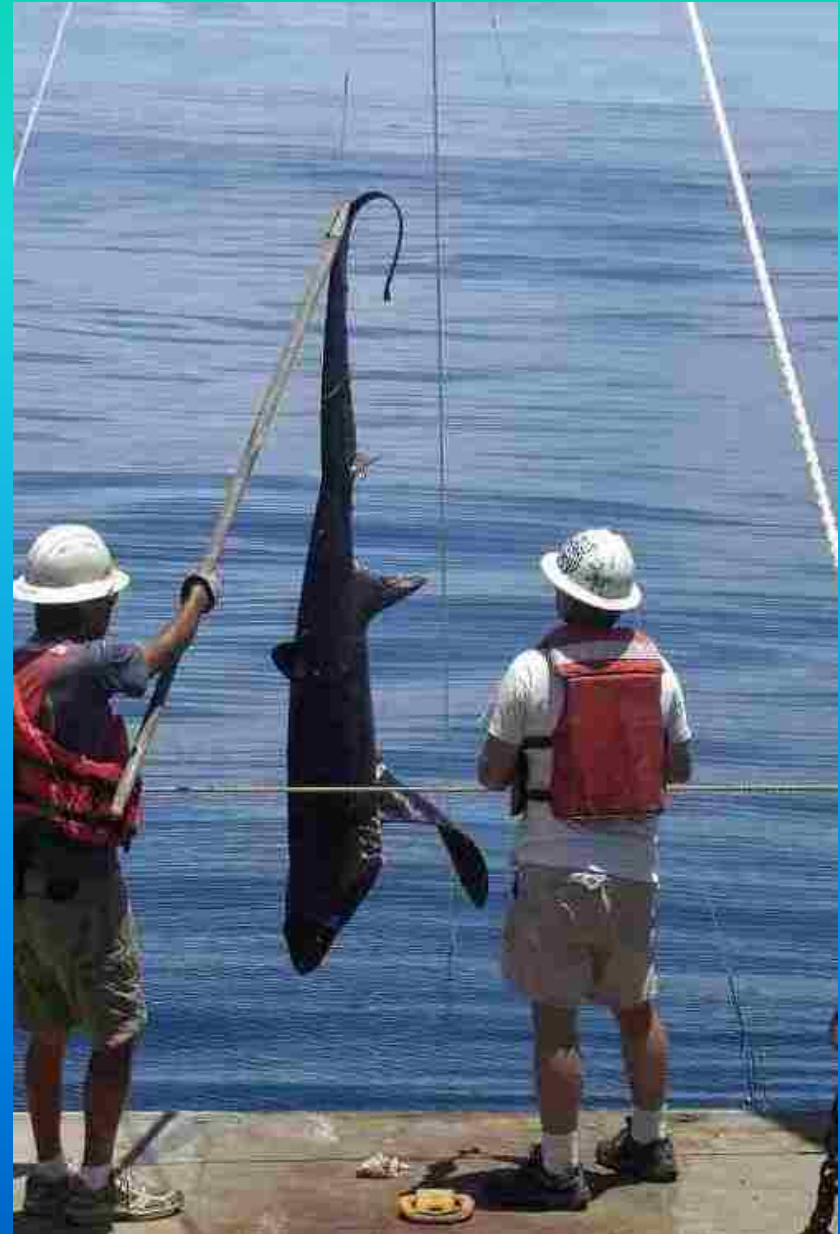
Fishing line can contain
unexpected bi-catch.

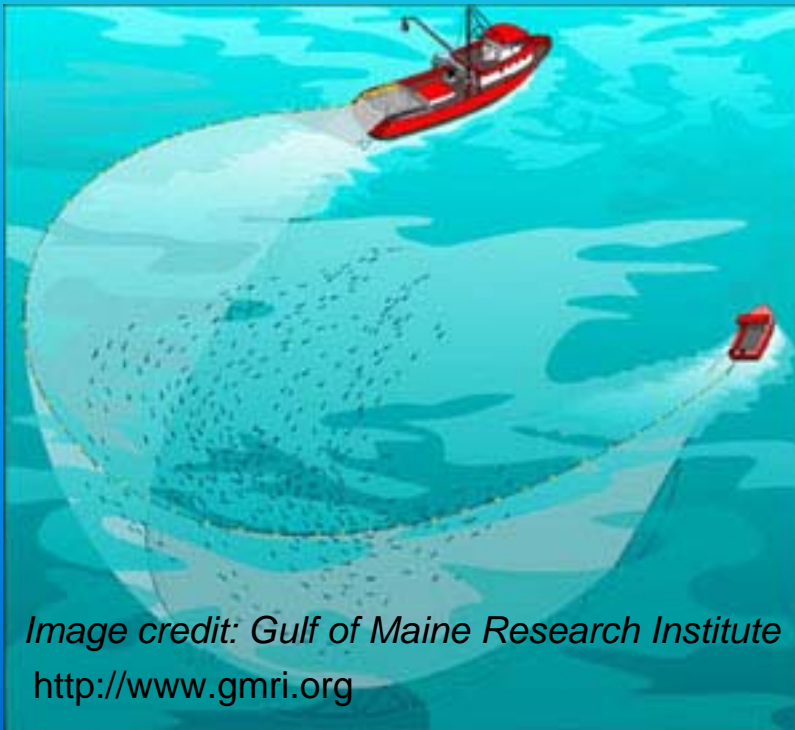
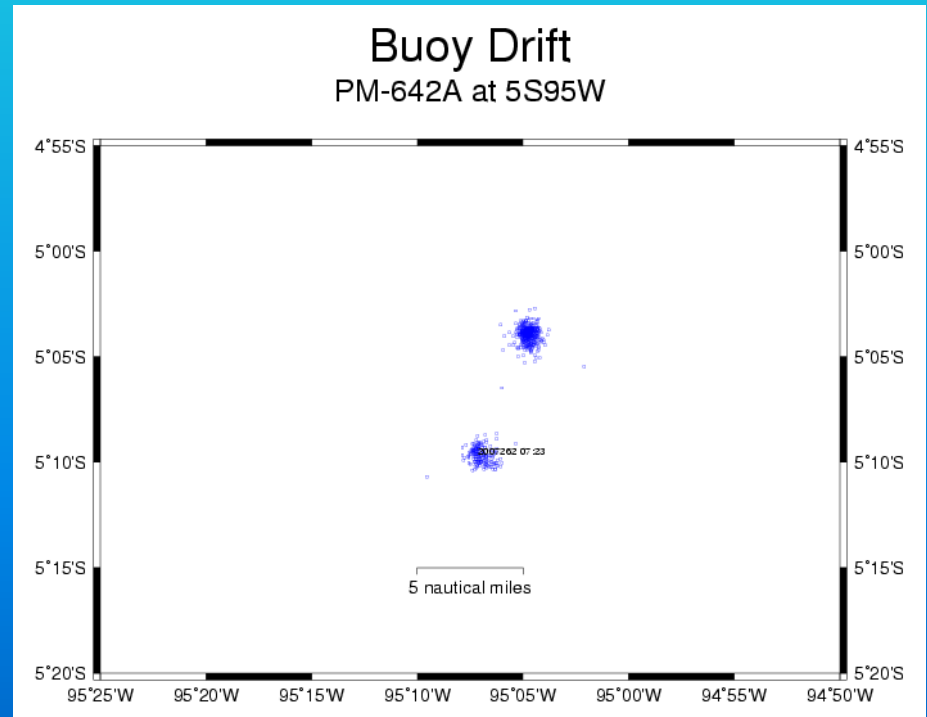
Purse seiners slowly pull buoys several miles, setting their nets around the buoy and the fish attracted to the “FAD”. They then release the buoy and close the net. This “sling shot” method increases their catch, but can damage moorings to the point that they are separated from their anchors.

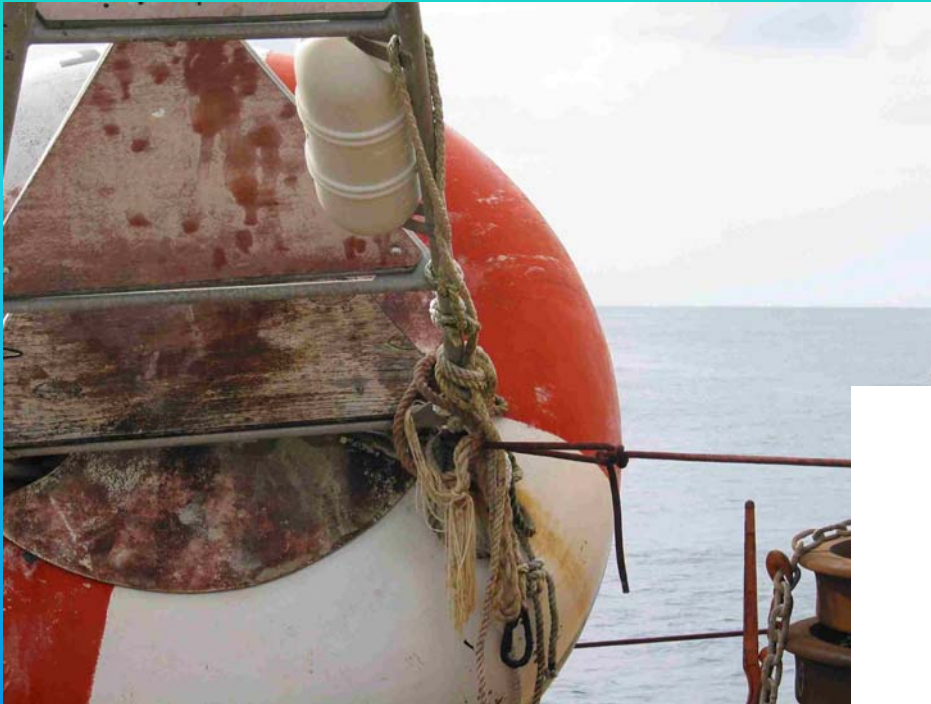
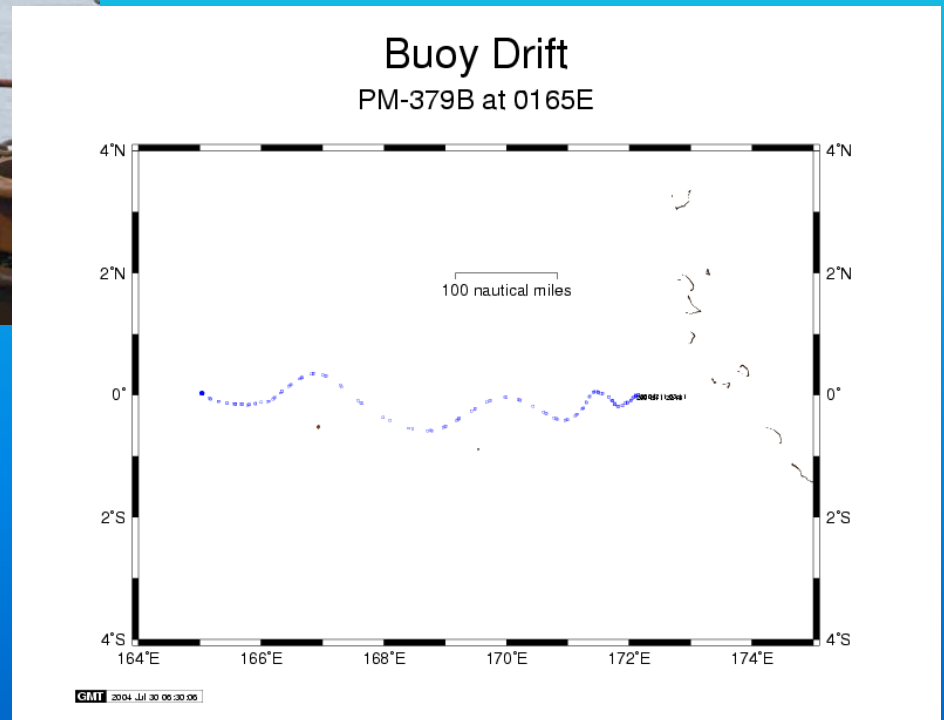
0° 165°E

Mooring drifted for 2 months before being recovered. Had hawser attached.

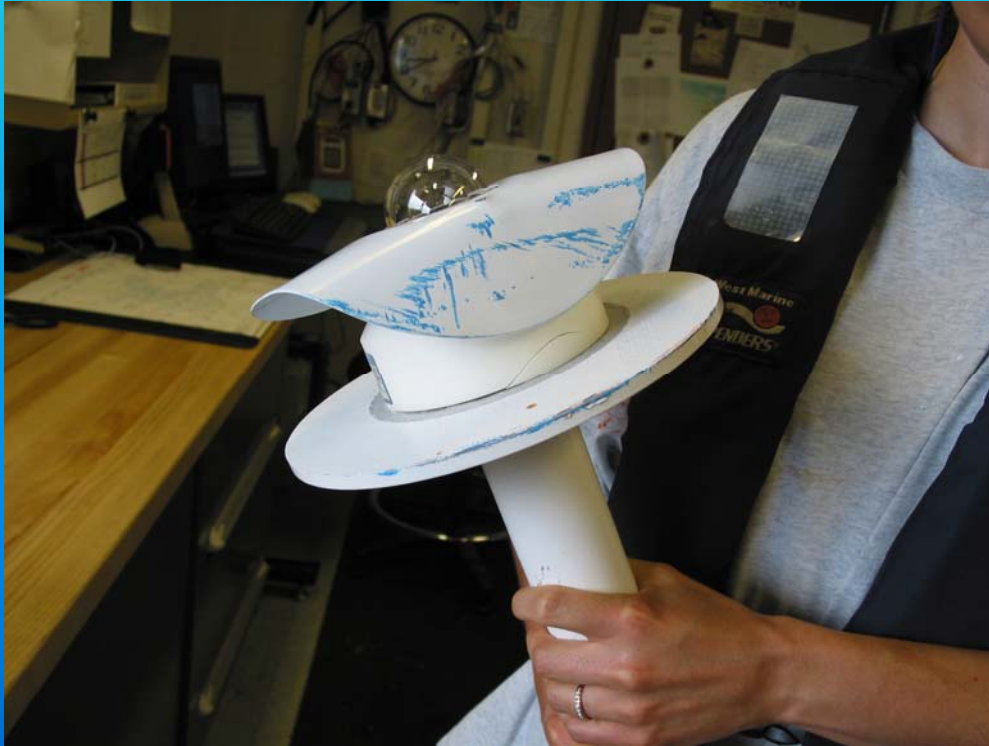
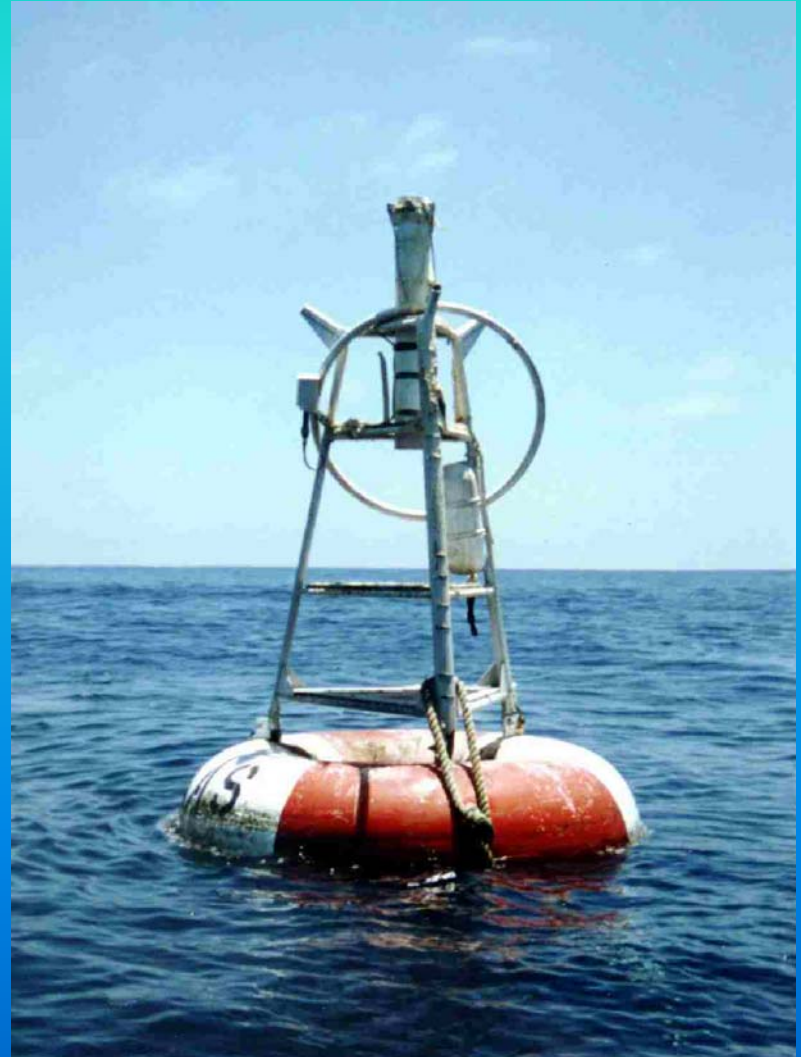
- Damage to buoy and sensors can occur when large ships tie up to moorings

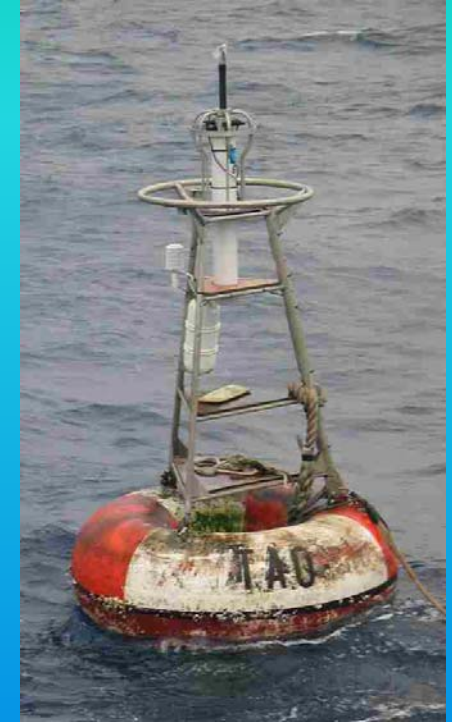
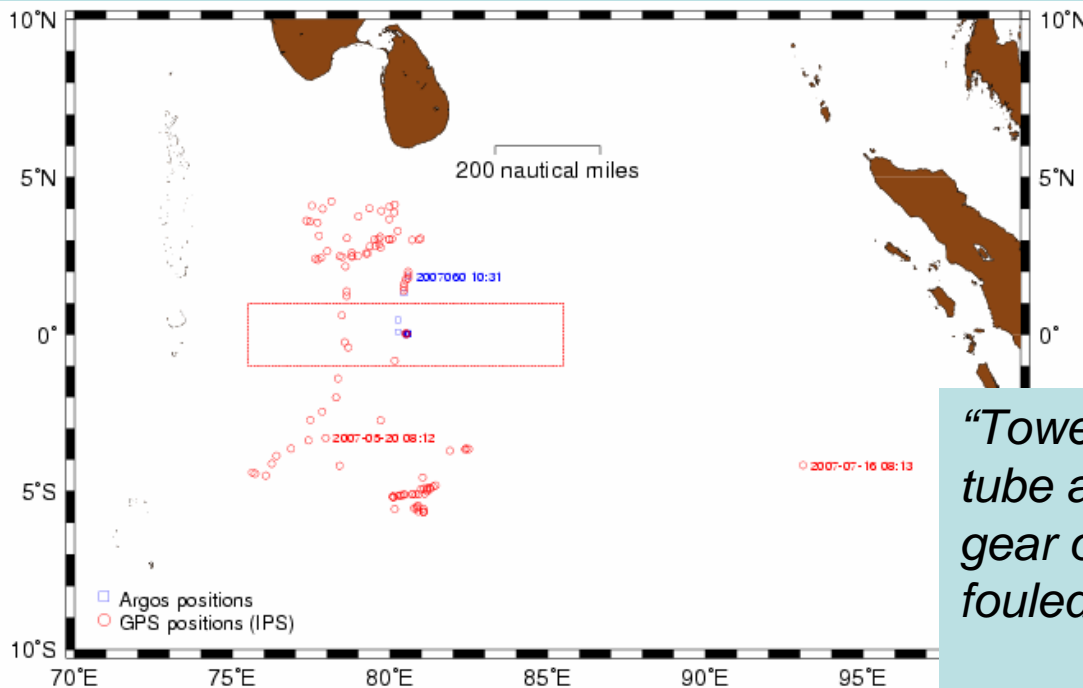
0° 90°E Mooring Recovery Log

*“Tower stripped of sensors, except
tube and barometer, lots of fishing
gear on bridle, plus float. Fishing gear
fouled at 10m, 20m, 50m, 100m.”*

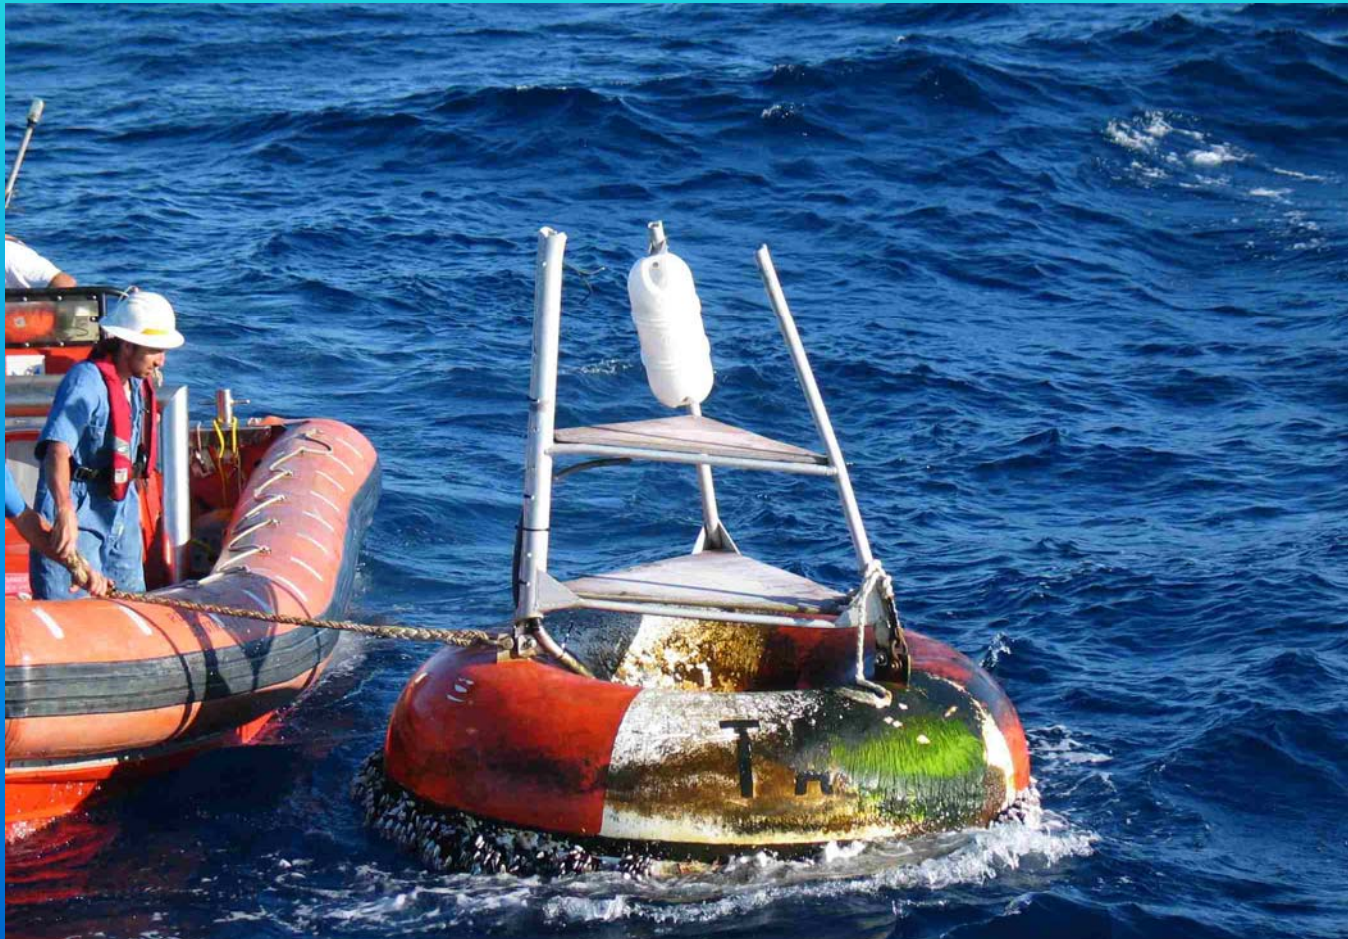
All or a portion of the buoy tower may be removed, either by unbolting or cutting.

Hardware used to attached sensors and the buoy tower will require special tools.

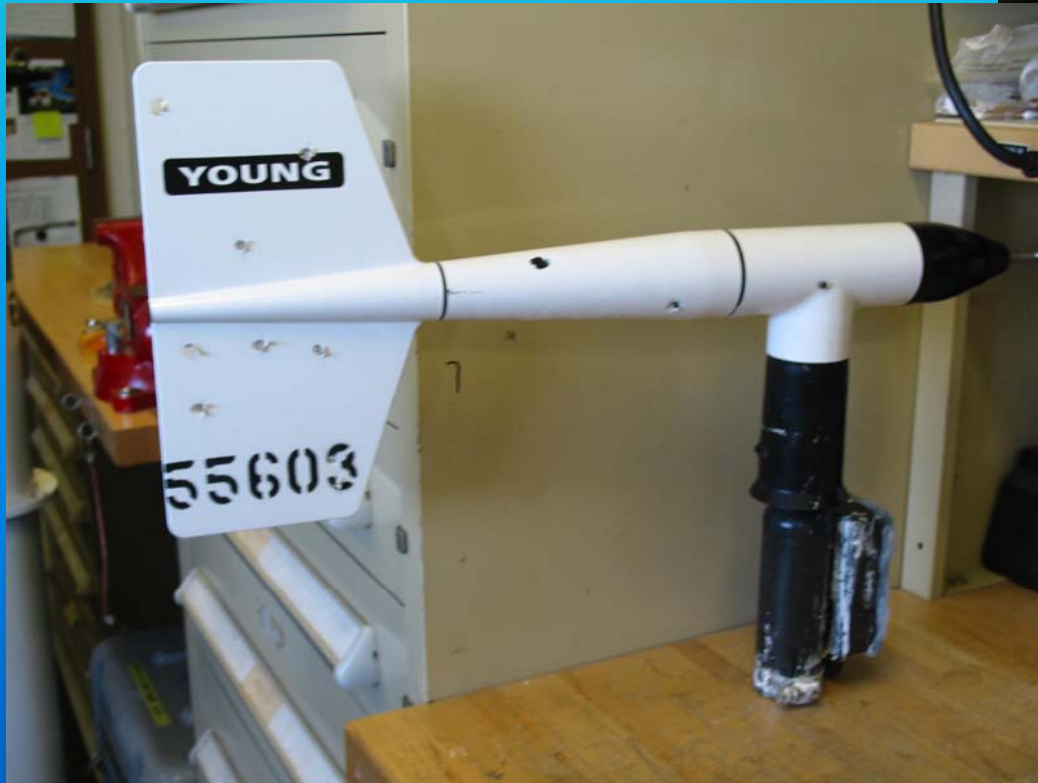
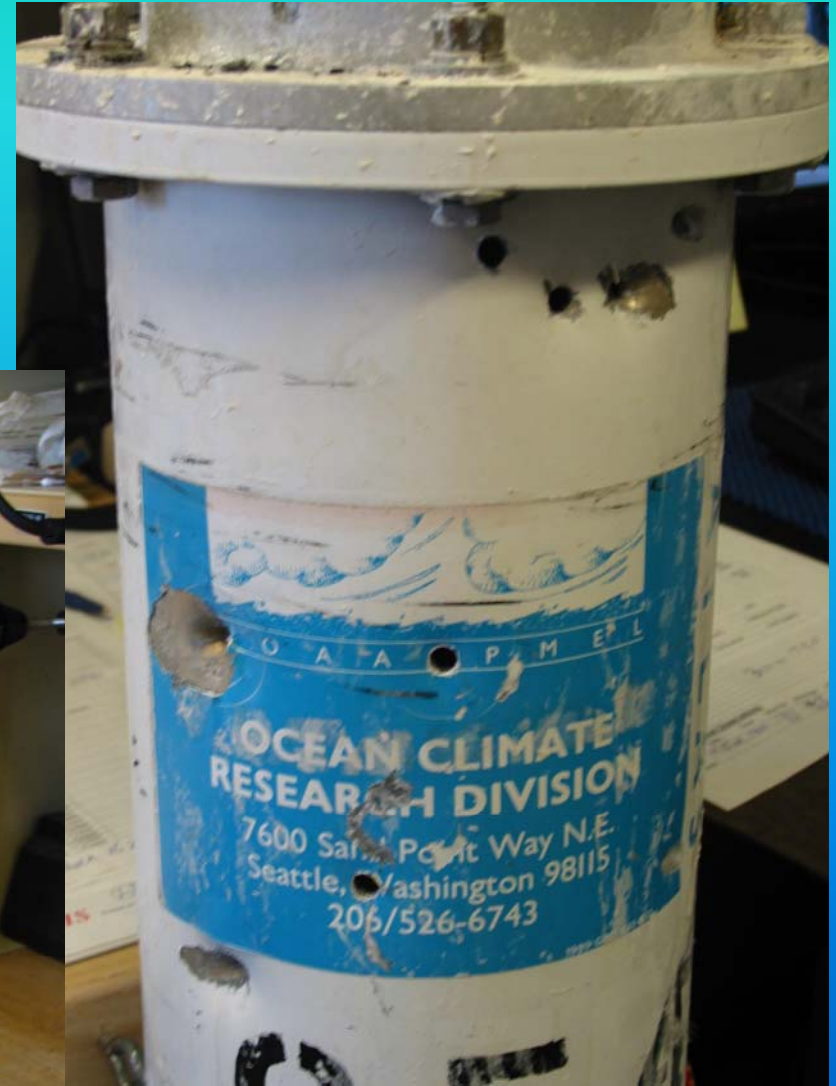
Buoys have been used for target practice.
