# Experiment to Test Low Concentration Volcanic-Ash Ingestion by a Jet Engine

October 22, 2015  
Anchorage, Alaska

## Vehicle Integrated Propulsion Research (VIPR) III

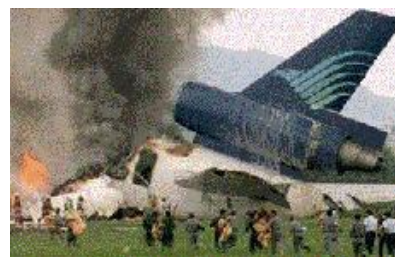
Propulsion System Malfunction combined with Inappropriate Crew Response Accidents

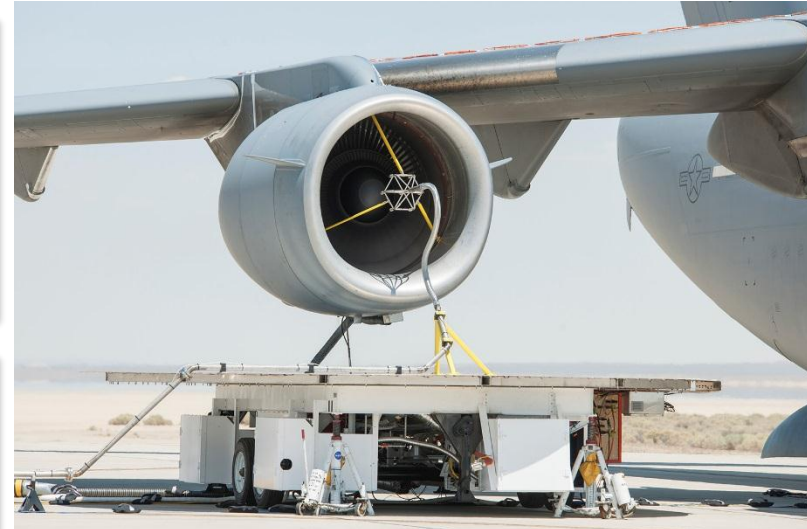
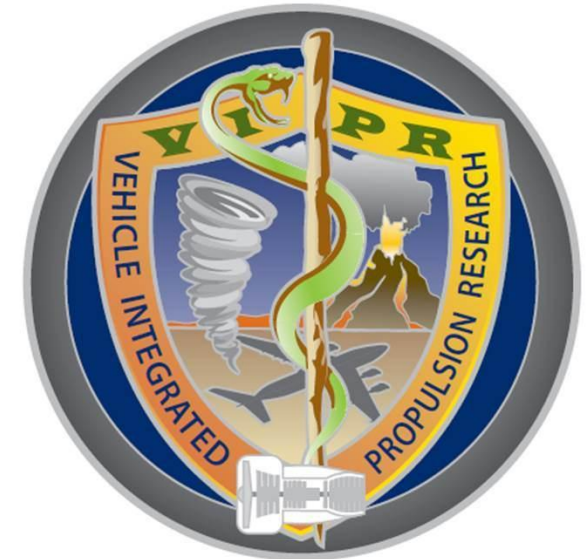
## VIPR 2 (JULY 2013): INTEGRATED CORE SENSORS

- SUCCESSFULLY INTEGRATED EXPERIMENTAL TECHNOLOGIES
  - MICROWAVE BLADE TIP CLEARANCE SENSOR
  - THIN FILM PRESSURE SENSORS
- DETECTED & CHARACTERIZED INDUCED FAULT IMPACTS

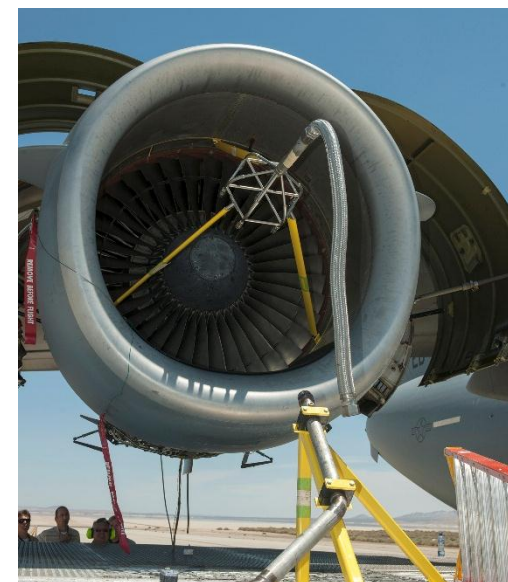
- **Advanced Instrumentation installed on engine and initial testing and check out occurred during hanger integration test February 2015**
- **Engine: Commercial variant that was significantly modified to demonstrate the VIPR technology and additional sensor suite installed on wing of an aircraft May 2015**
- **Testing**
  - Test Start Date: June 16, 2015
    - Combined Systems Test (CST)
    - Bleed Air Extraction & Sampling System (BAESS)
    - Engine Health Management (EHM)
    - Volcanic Ash Environment (VAE)\*
  - Test Completion: August 5, 2015
- **5 Volcanic Ash Ingestion Tests completed**

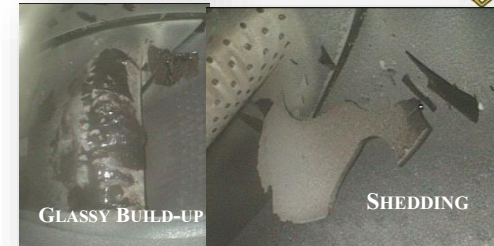
GLASSY BUILD-UP

SHEDDING

**RESULTS:**  **VERIFIED COMPRESSOR BLADE EROSION**

**TURBINE MOLTEN ASH GLASSY BUILD-UP**

**ASH SHEDDING**

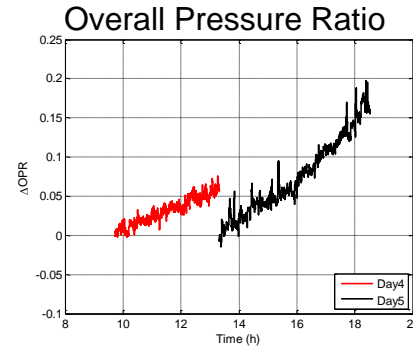
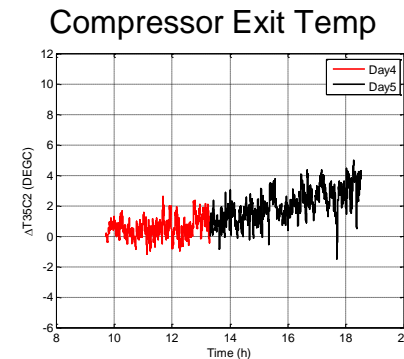
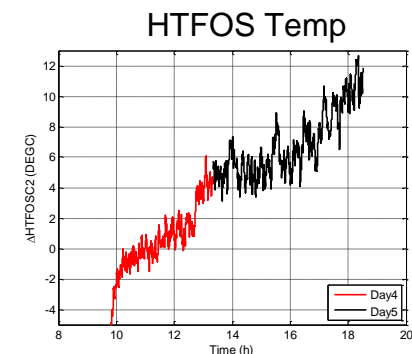
# Gas Path Measurement Data

- Five (5) days of volcanic ash ingestion testing
  - Days 1, 2, and 3 ran low concentration ash ingestion
  - Days 4 and 5 ran higher concentration ash ingestion
- No significant engine performance variations were observed during low concentration ash runs
- On high ash concentration run days, discernable performance trend changes were observed in overall pressure ratio (OPR), fuel flow, compressor exit temperature, and exhaust gas temperature.
- Advanced sensor data tracks performance changes observed elsewhere in engine
  - High Temperature Fiber Optic Sensor (HTFOS) trends with exhaust gas temperature
  - Thin Film Thermocouple (TFT) trends with compressor exit temperature

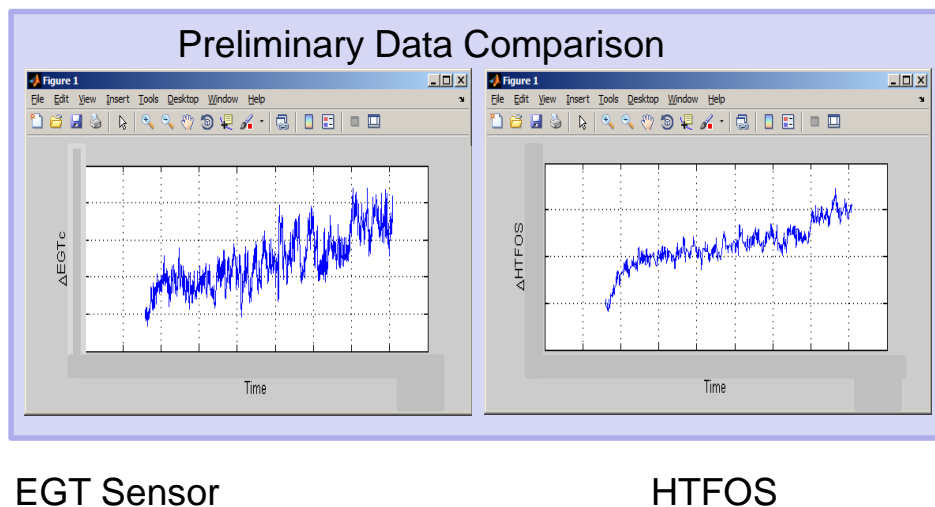
# High Temperature Fiber Optic Sensor

- Evaluate the sensor performance in the engine exhaust plume under various engine operating and ash ingestion conditions.
- Compare results with the EGT sensor data

- Shown capable of withstanding thermal and vibrational environments of the jet engine exhaust
- Significance of the sensor is immune to EMI and EMP, has high resistance to chemicals, low noise, signal fidelity, low maintenance
- Preliminary results show lower noise than existing EGT sensors

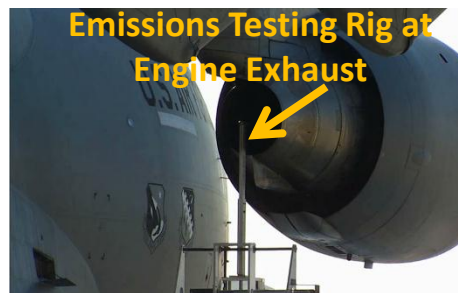
CO sensor

Sensor probe

Sensor probes in emissions testing rig manifold

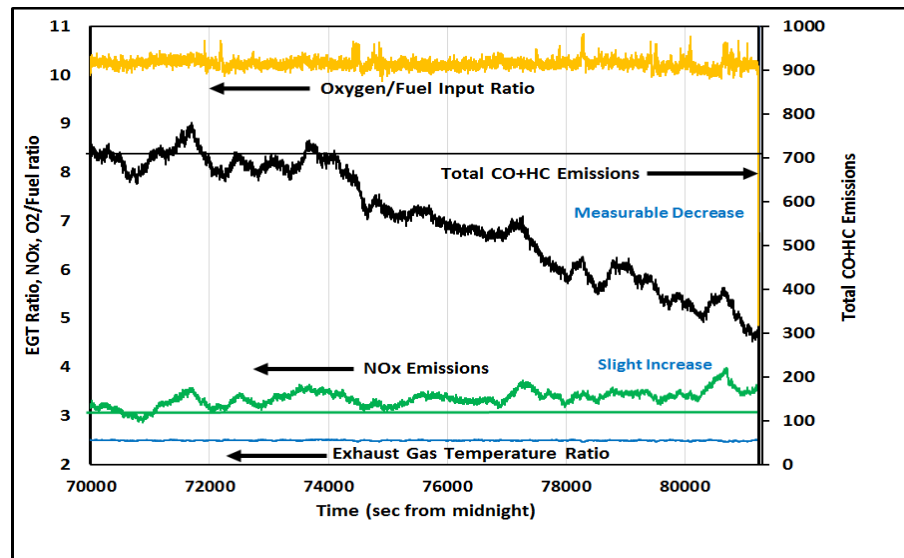
- Emissions Sensor Array Monitored Engine Emissions during Days 1-3, 5 of Ash runs
- Days 1-3: Candidate “Steady-State” Emissions Parameter Identified
- Day 5 Deviation in “Steady State” Emissions Profile Suggestive of Change in Engine State During Heavy Volcanic Ash Deposition
  - Not Presently Explainable By Reference to Other Engine Parameters

Preliminary Emissions Data – Patterns Established/ Deviations Observed Suggesting Possible Volcanic Ash Effects
