Assessment of the catastrophic events originated in the river Vere basin

Presenter: Irakli Megrelidze – Deputy Head of Hydrometeorological Department
(National Environmental Agency)

Hydrology Forum, 20-23 September 2016, Oslo, Norway

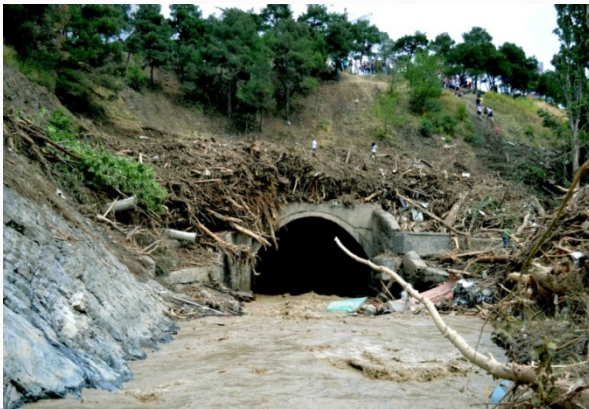
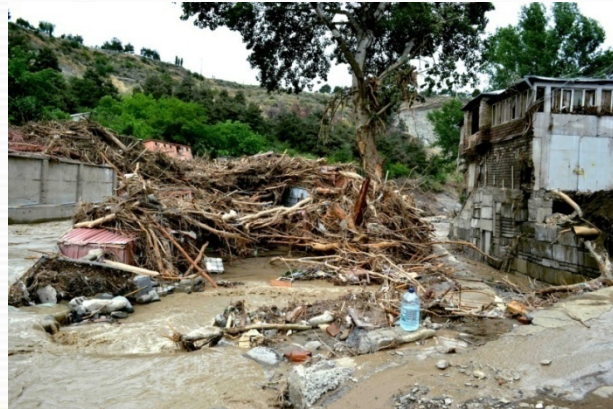
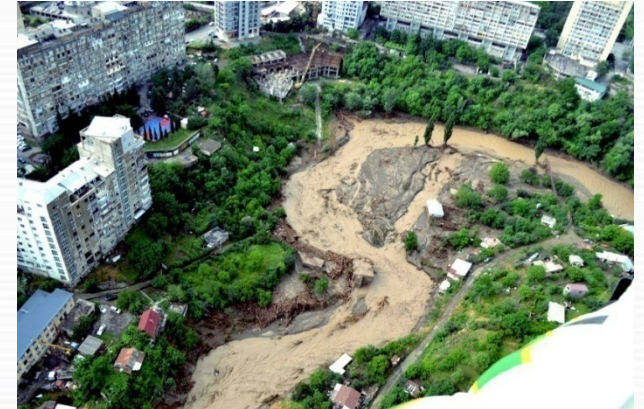
- Simultaneously occurred several disasters: **Landslide, mudflow, flash-flood, bank erosion, rock fall and hail**;
- Landslide from **800 thousand to 1 million** cubic meters of ground masses generated at the left slope of the river;
- During 3-4 hours, from the calculations, the amount of precipitation reached **100 mm**;
- Tbilisi meteorological station has fixed **49 mm** precipitation (which is 67% of the norm for June), in some places of Tbilisi rain wasn't fixed;
- Water discharge compiled **468 m³/sec** (calculated by the water traces);
- Compared to the average multi-year level, the current level in Vere gorge rose **3.4-4.0 meters**, in some parts **18-20 m**;
- **Trees has blocked the entrance of the tunnel** (culvert), the culvert was calculated for 450 m³/sec discharge.

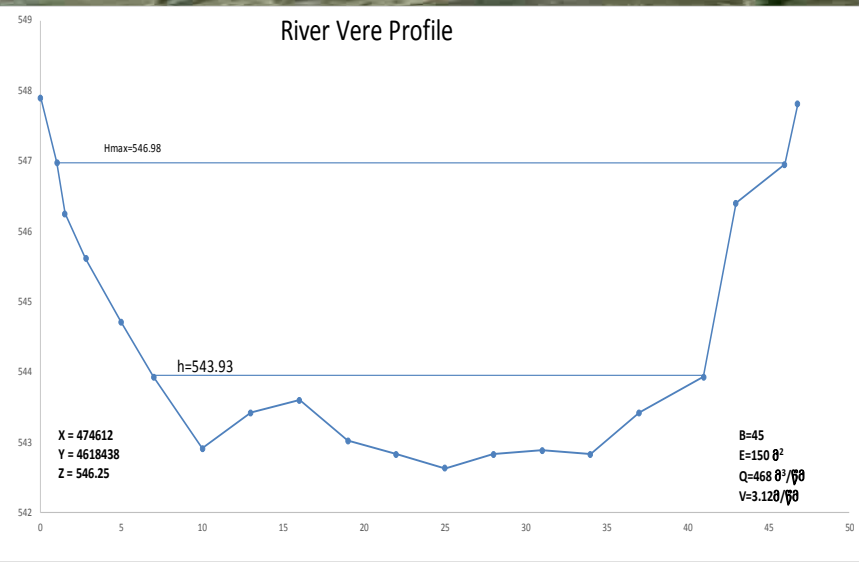
River Vere Profile

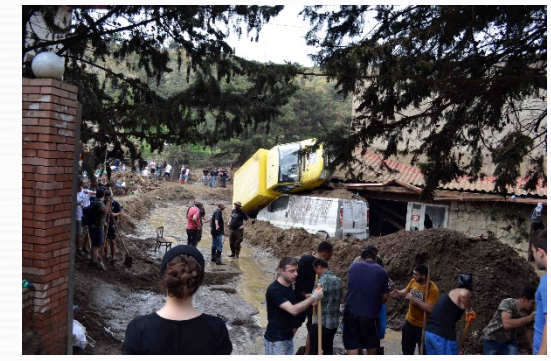
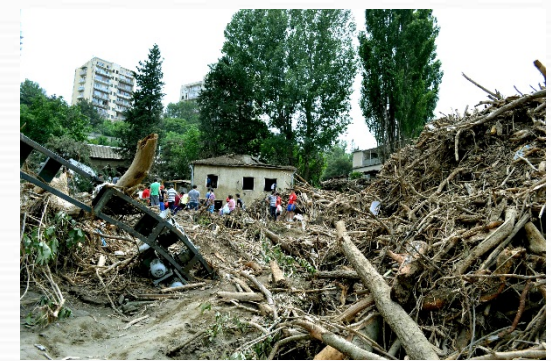
Flooding zone of the tunnel located at Svanidze str. in the Vere River gorge

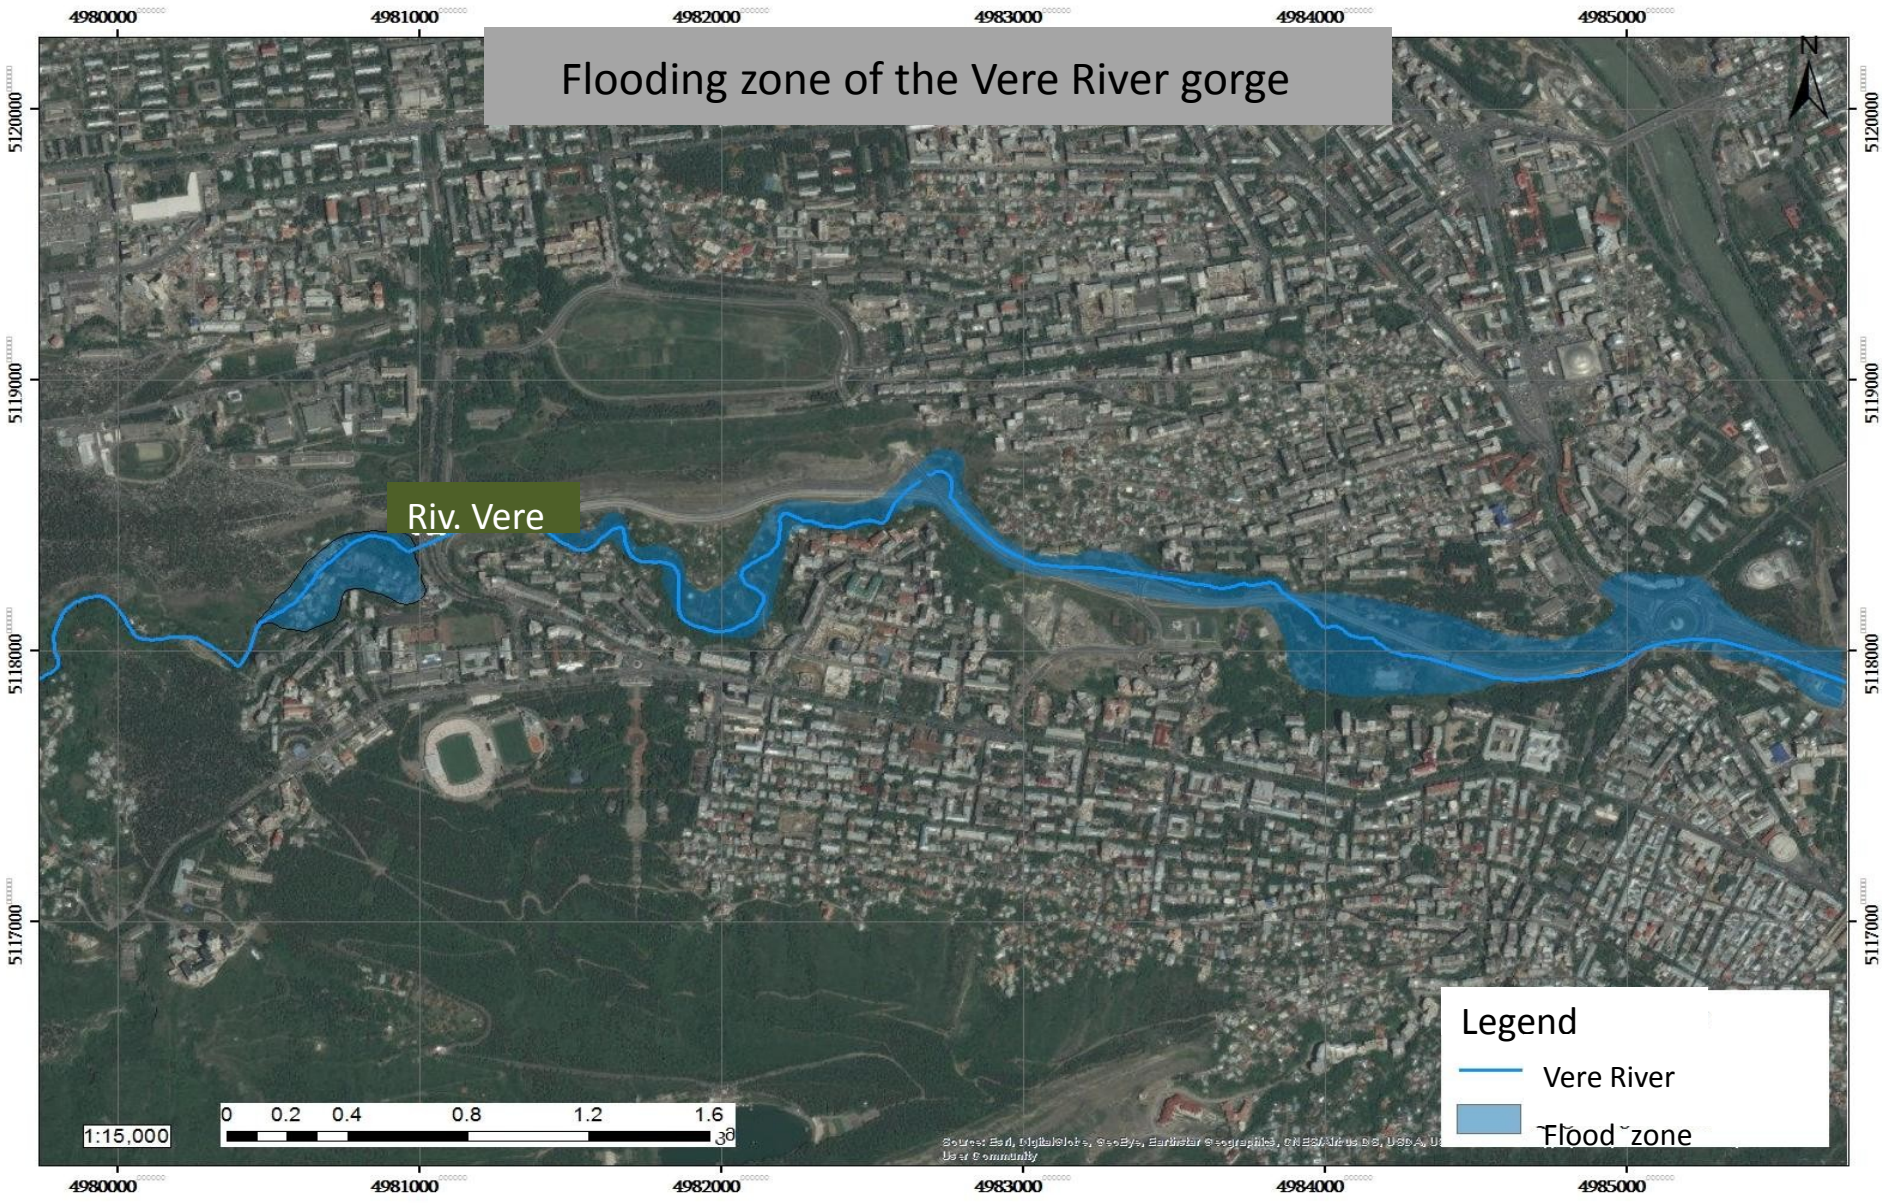
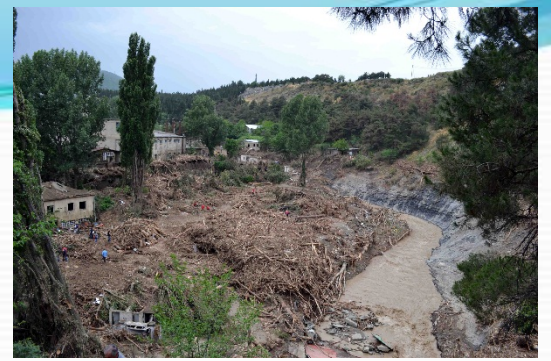
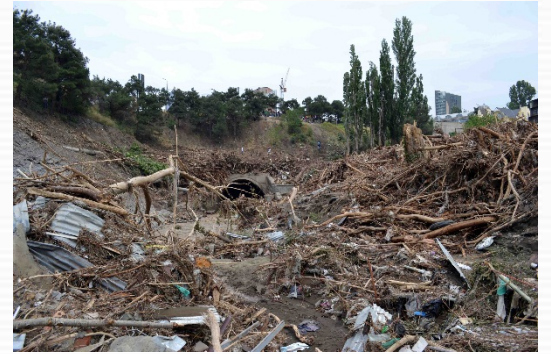
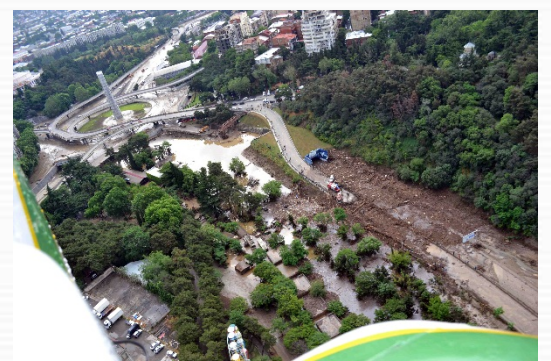
Flooding zone of the Vere River gorge

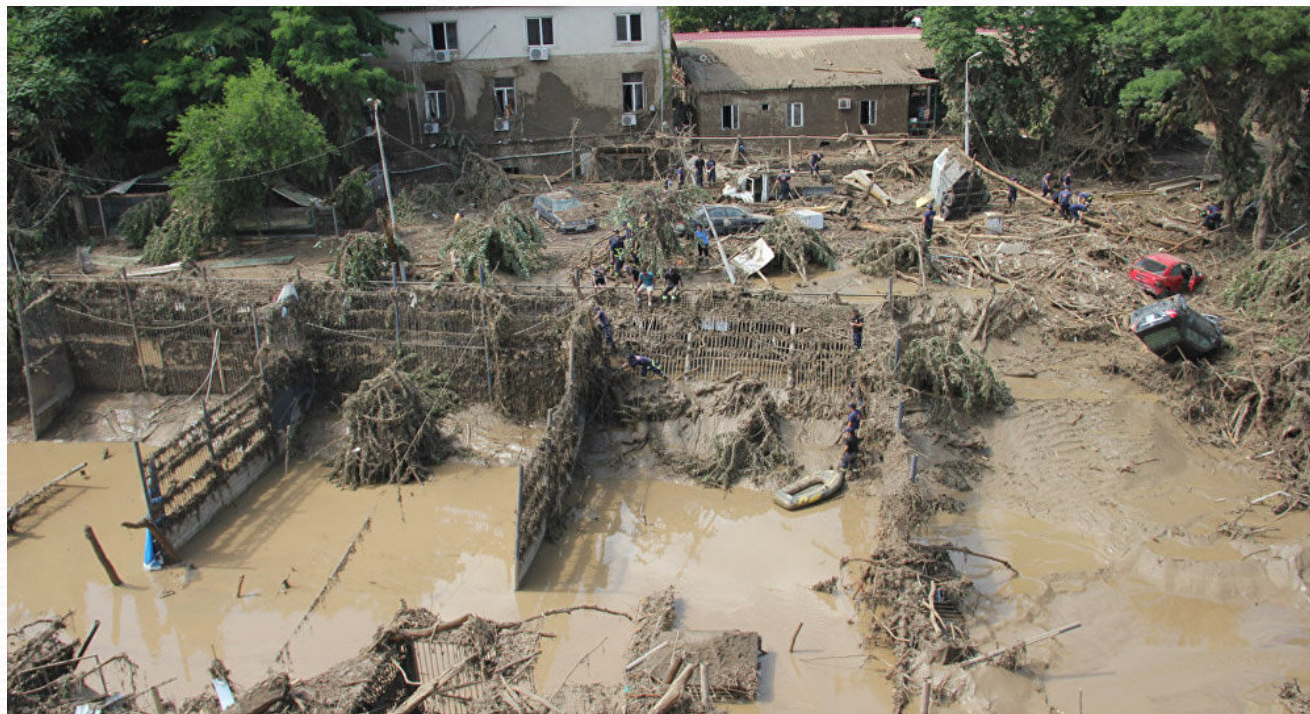
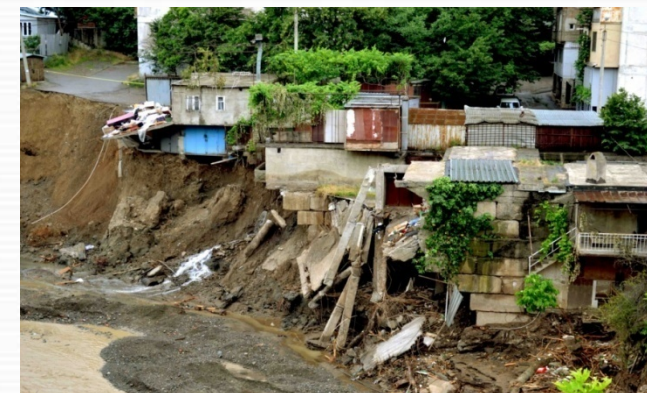
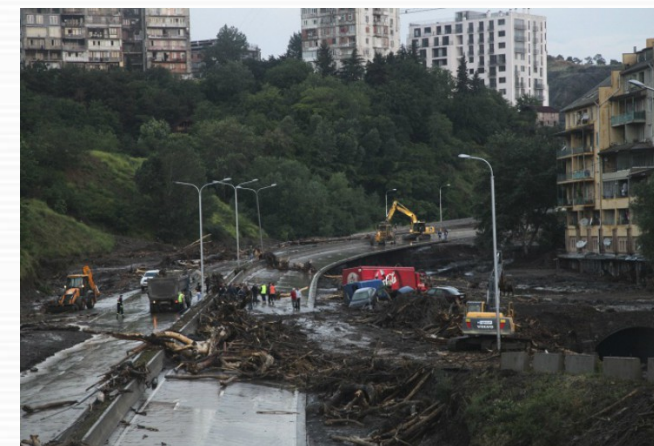
Due to the Vere disaster, the houses, various infrastructure facilities, buildings located below the lowest mark of the River gorge, as well as Tbilisi Zoo were significantly damaged and/or destroyed. According to the latest data, 20 people died and two people are missing
