South Asia Flash Flood Guidance System Operational Training (Step-4) (New Delhi, India, 5-7 June 2018)

A Flash Flood Case Study- Bhutan

1. Flash Flood Case Study- (Phuntsholing/Chukha)
2. Flash Flood Case Study- (Samtse)
3. Verification of case study

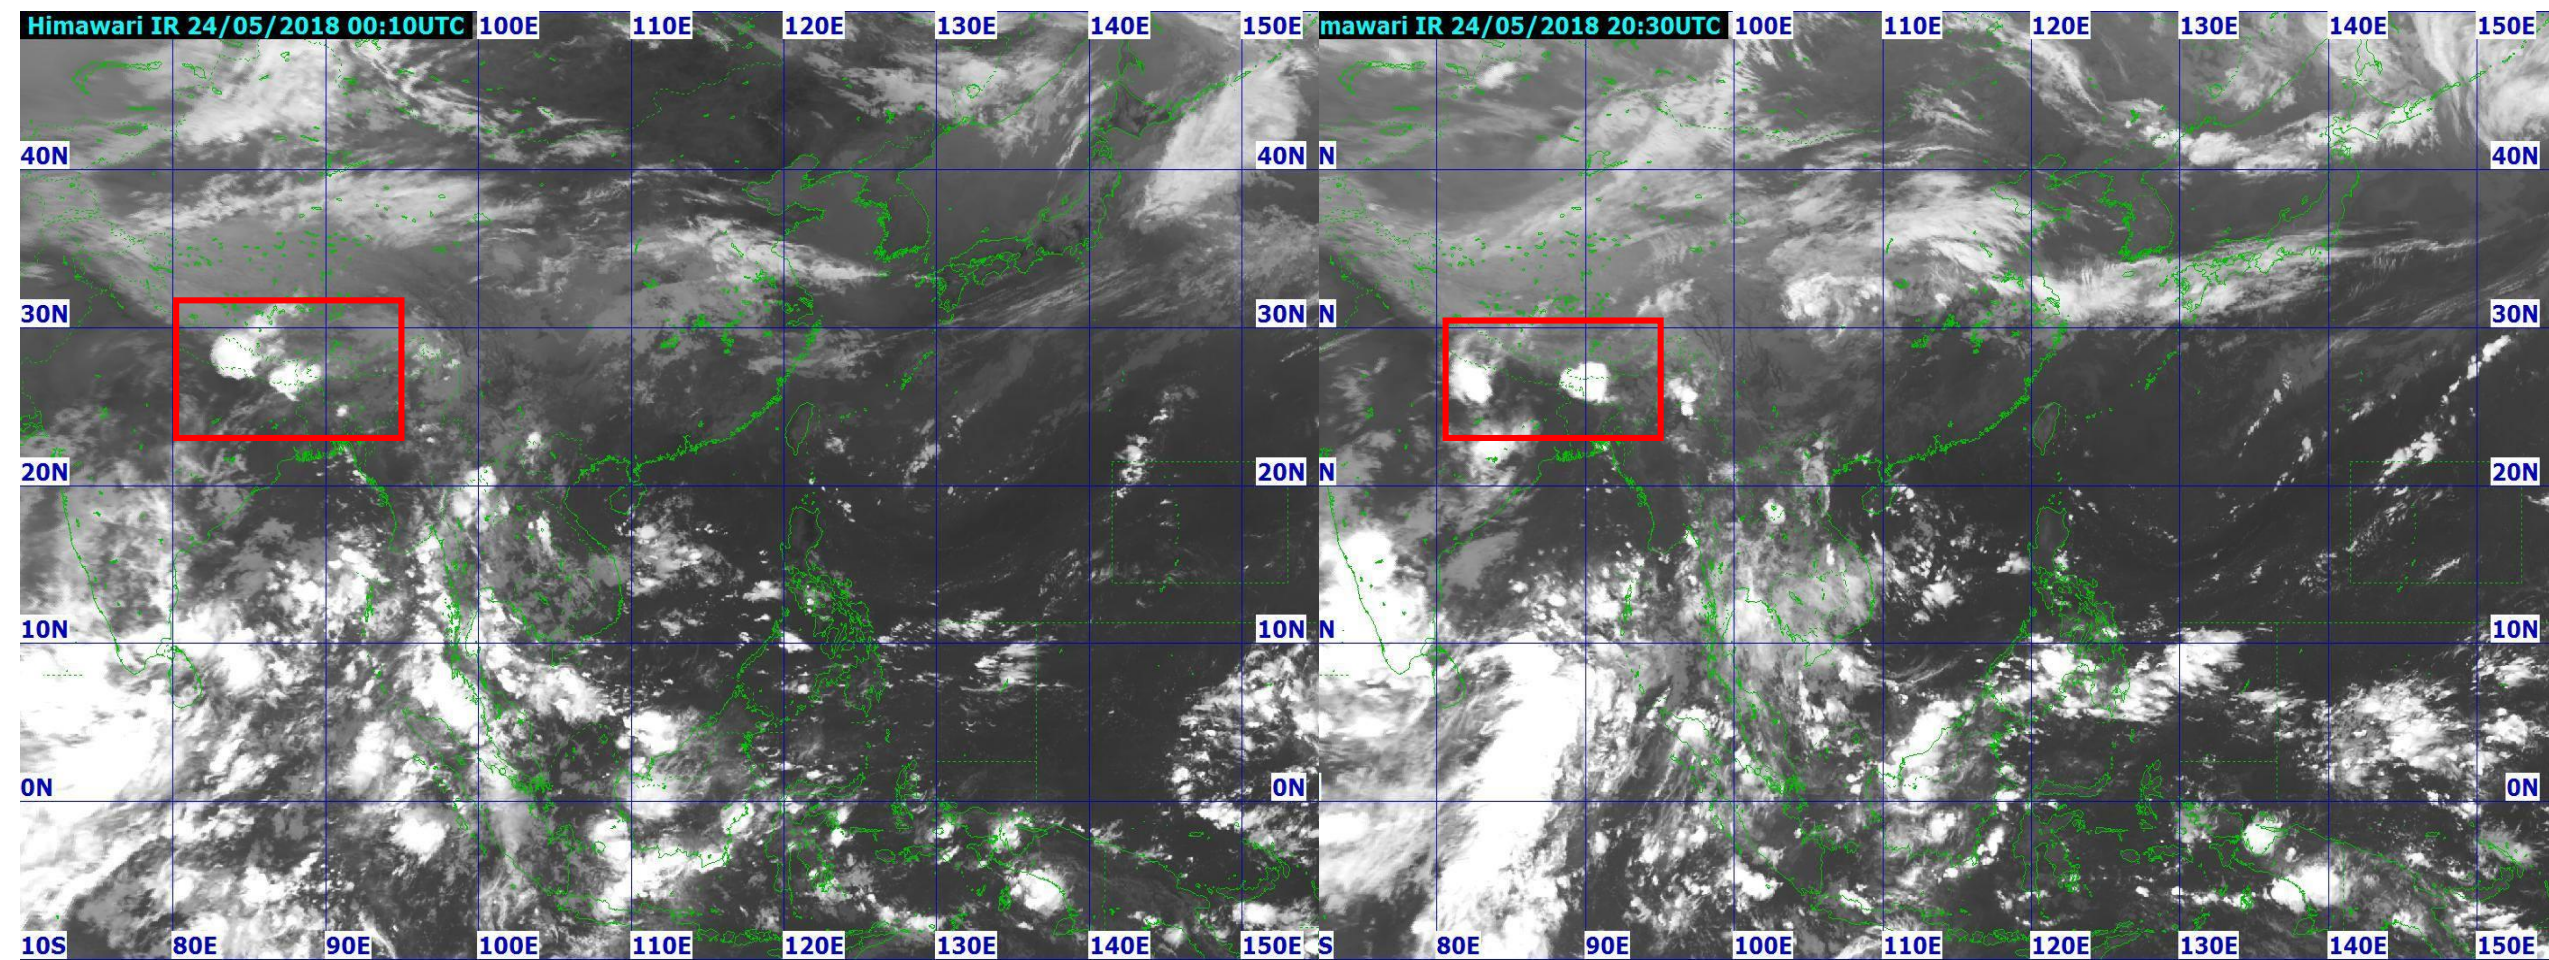
Hamawari-8/9 Satellite

Slow movement of a system had caused more rainfall and Flash Flood (Samtse and Phuntsholing)

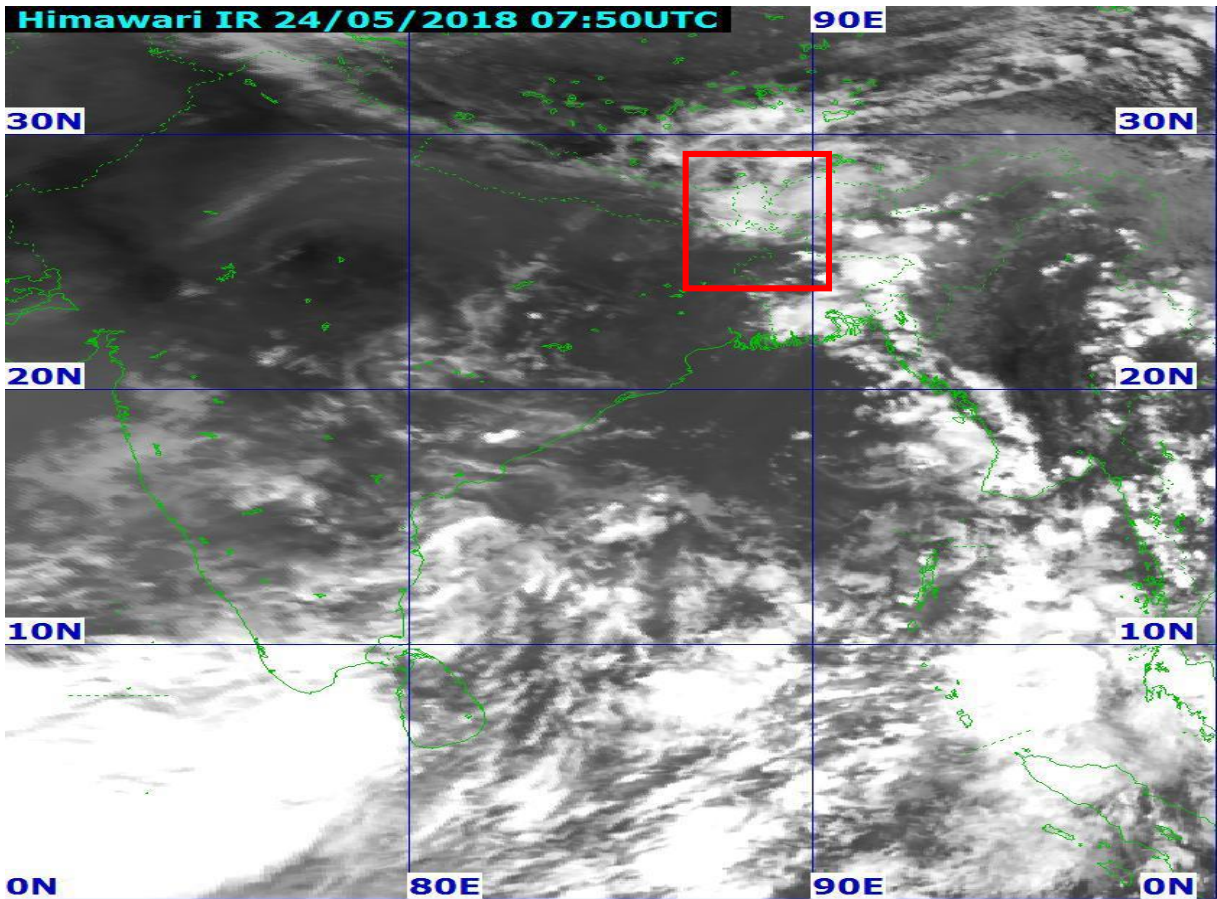
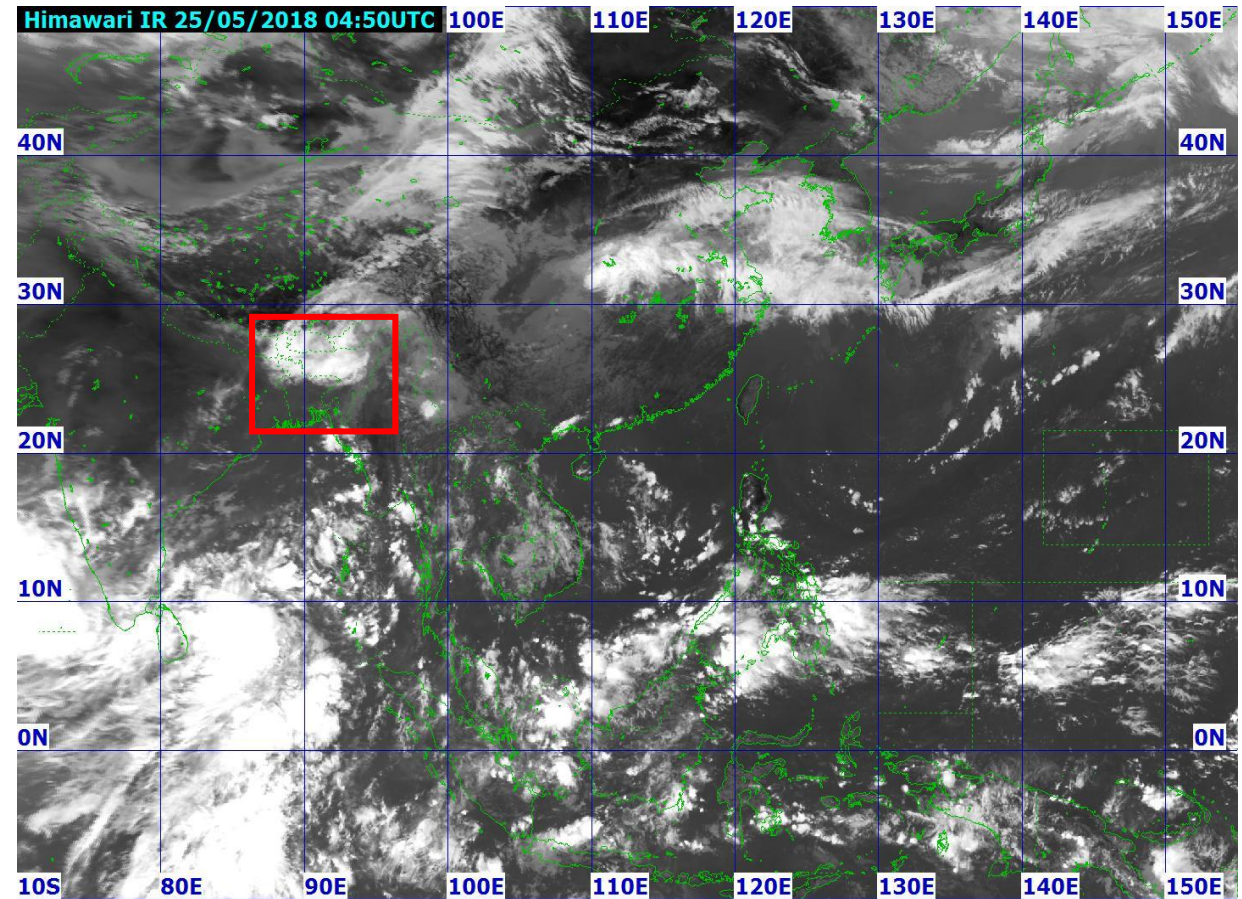
Hamawari-8/9 Satellite Images:24-25/05/2018

Slow movement of a system on 25th May 2018 had caused more rainfall and Flash Flood (Samtse and Phuntsholing)

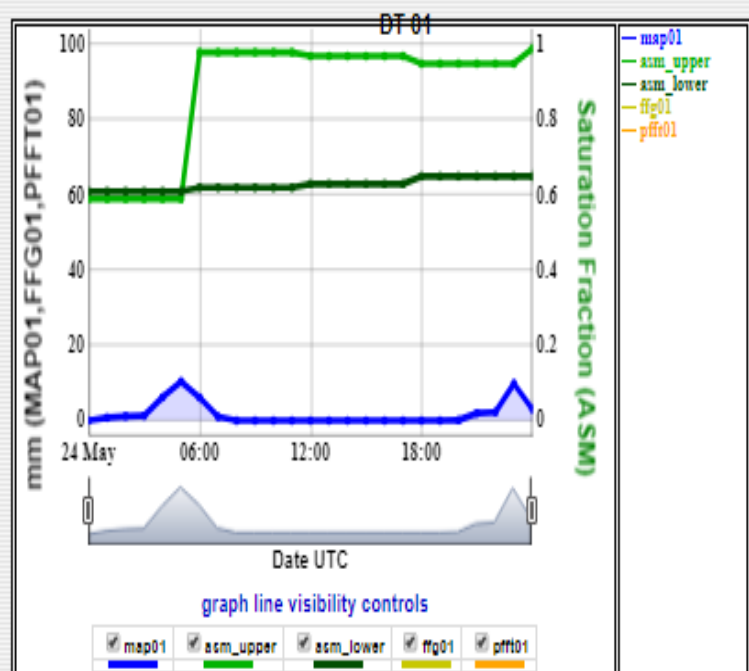
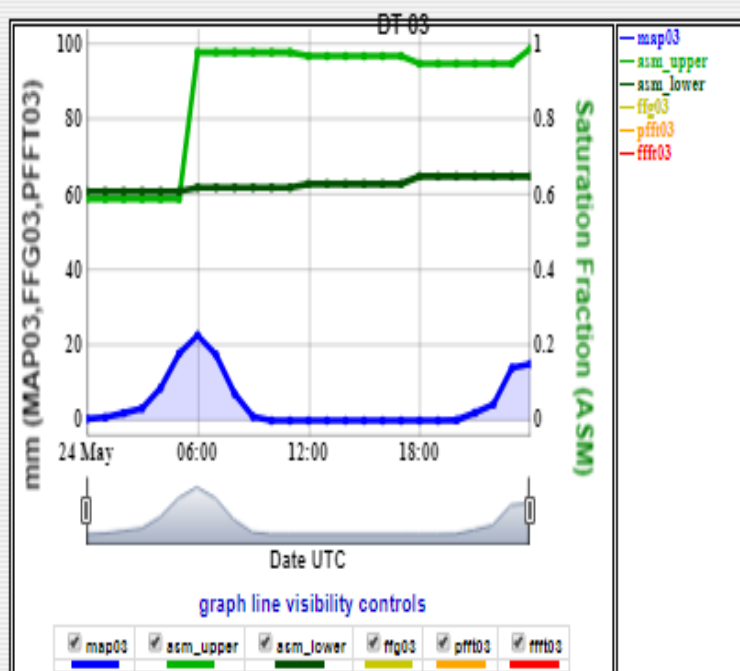
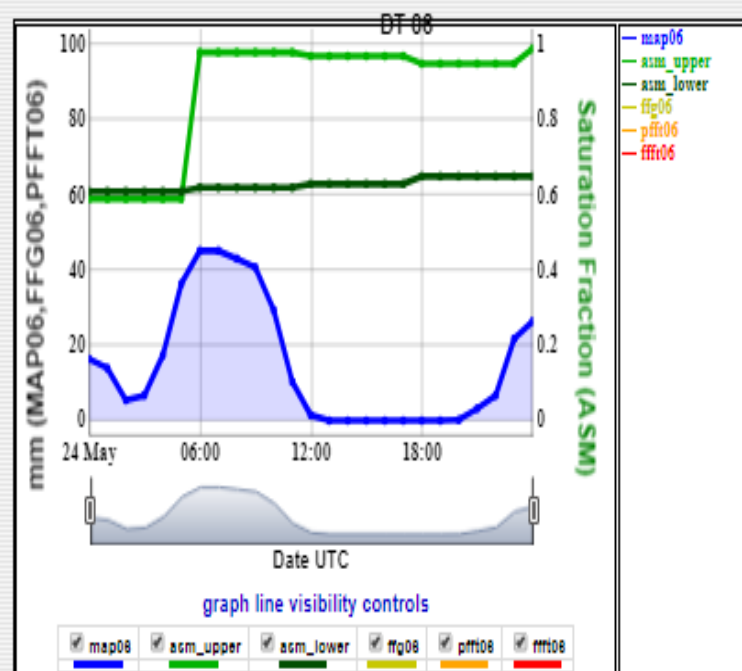
FFG-Gram plot demo - 1-hr, 3-hr, and 6-hr durations - Basin: 2022801650

Start: 2018-05-24 00:00 UTC End: 2018-05-25 00:00 UTC

Basin ID: 2022801650

1. FFG is showing flash flood possibility on date 24-25 in Phuntsholing.
2. It was found when there is continue rainfall then only showing in FFG
3. On dated 1st and 17th May, there was no warnings are shown in FFG. Therefore, reason are not clearly known???
4. It was found both MWGHE and GH is performing well as showing good signature of the systems.
5. It was found during dated 1st and 17th there was more rain but FFG (MWGHE and GH) is not showing well? Reason unknown? Local affect...?

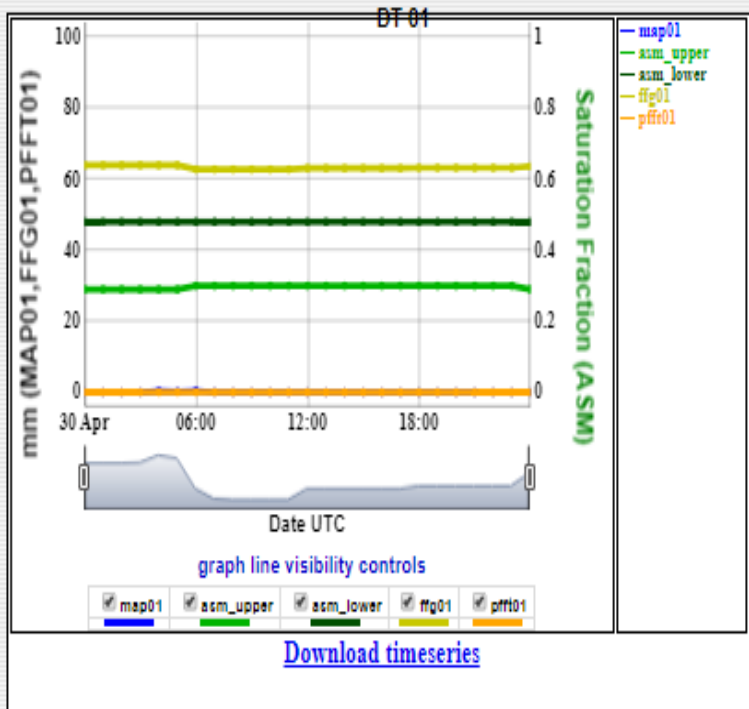
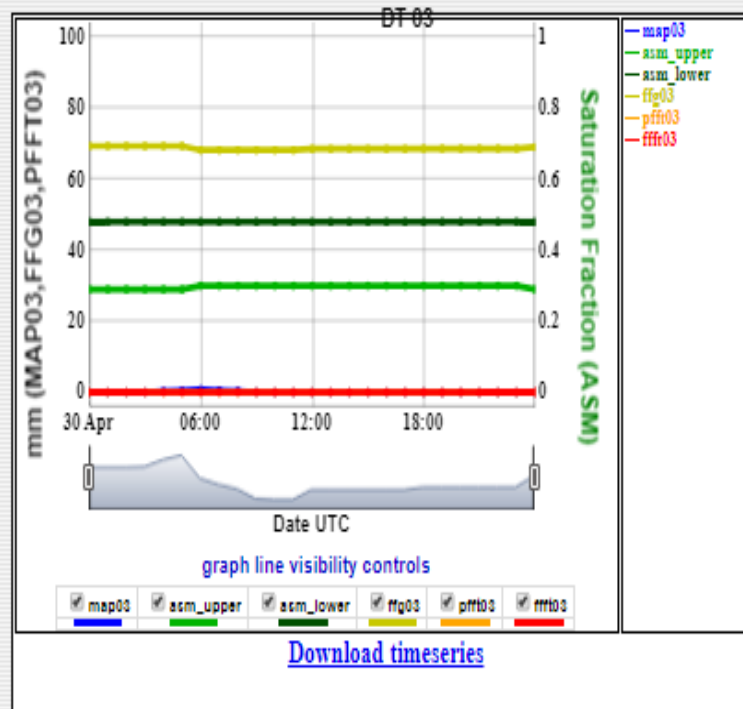
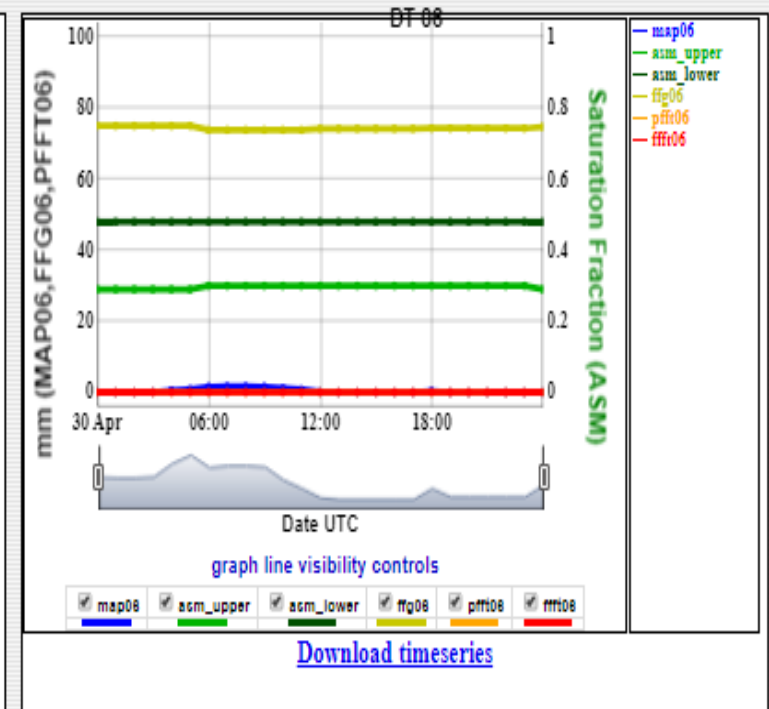
FFG-Gram plot demo - 1-hr, 3-hr, and 6-hr durations - Basin:

Start: 2018-04-30 00:00 UTC End: 2018-05-01 00:00 UTC

Basin ID: 2022801528

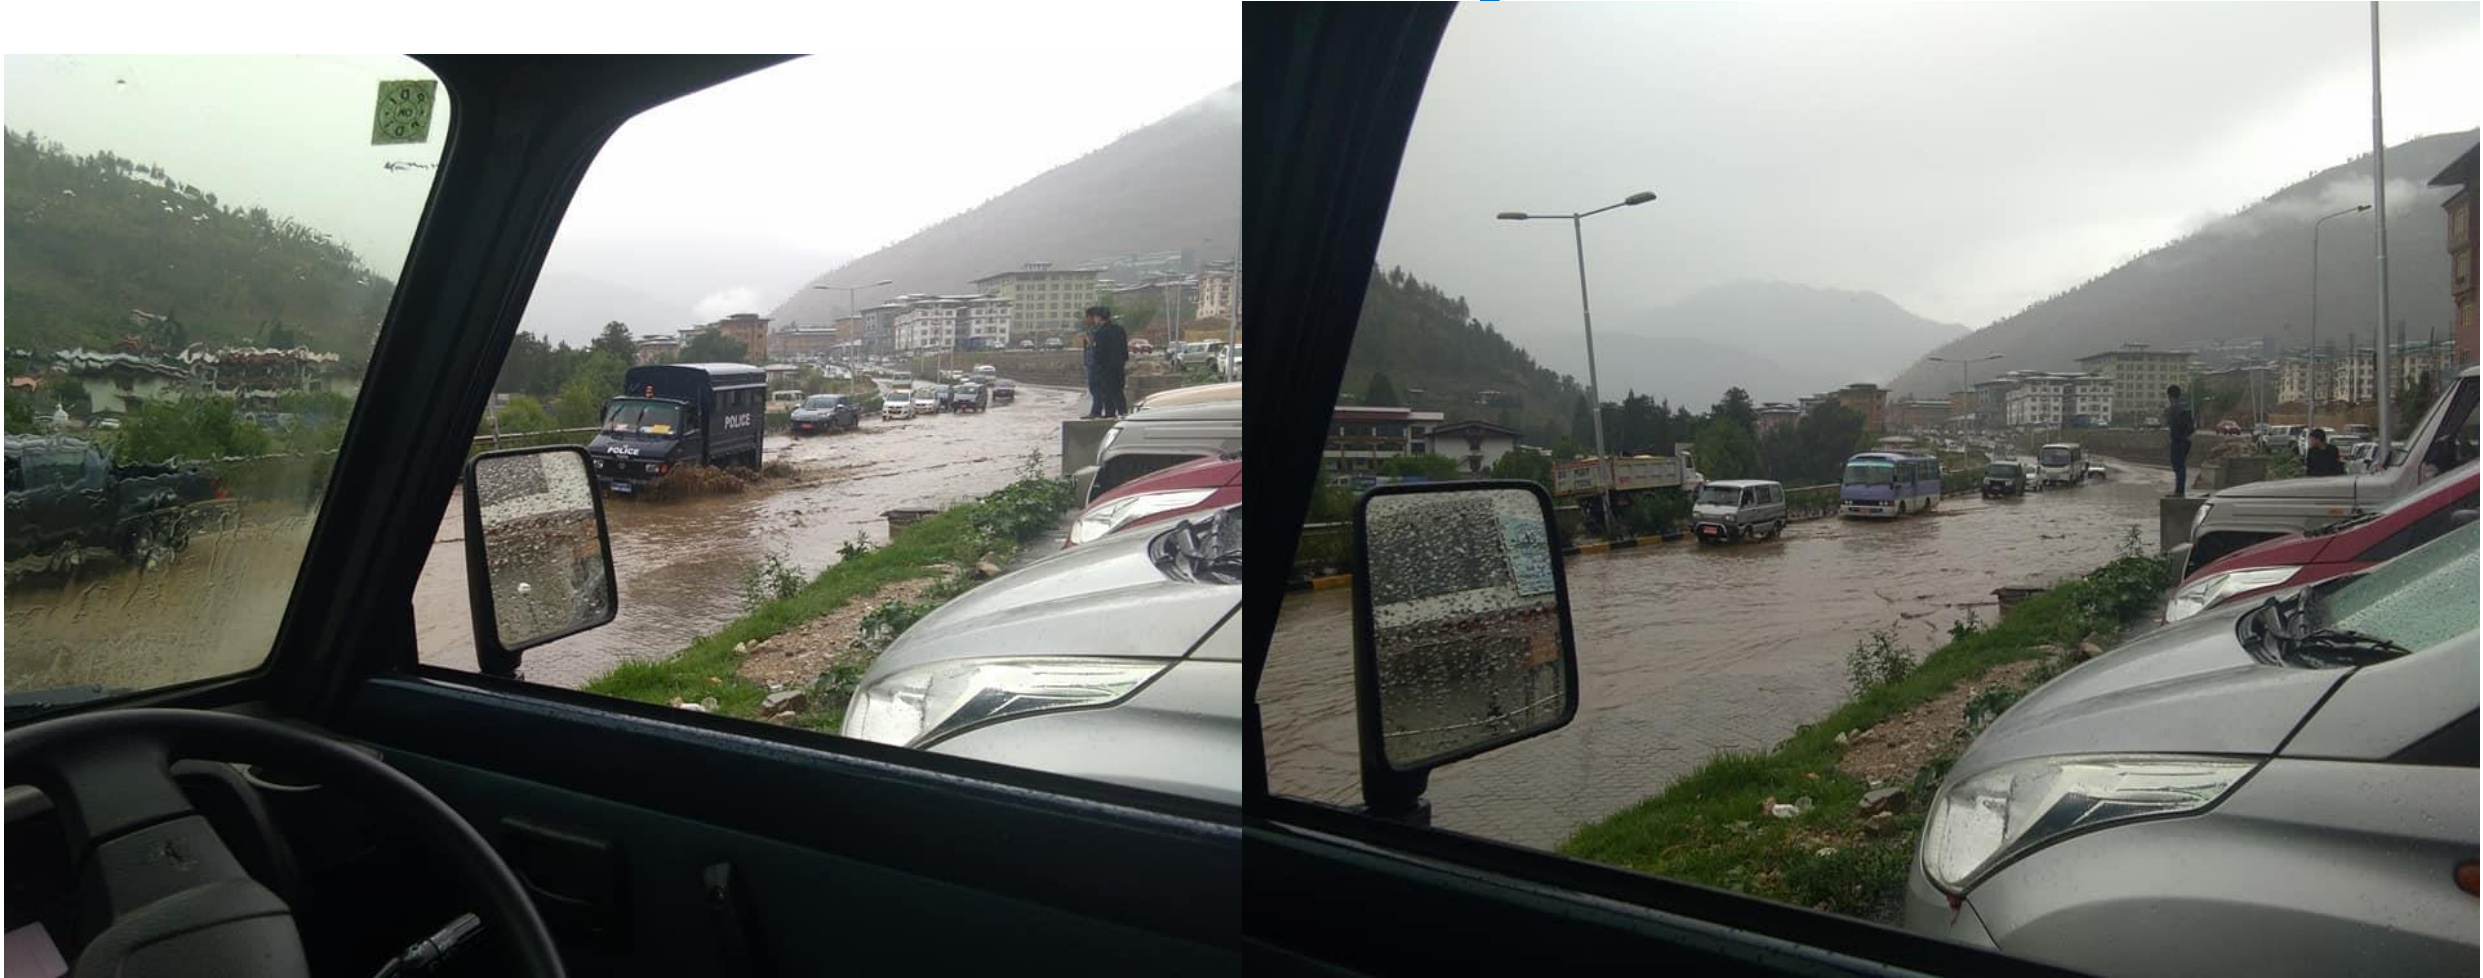
Urban Flash flood in Thimphu: 04/06/2018

May be this system is caused by cloud out burst, so urban flooding in nearby Thimphu city was seen
