Use of Ultrasonic Wind sensors in Norway

Hildegunn D. Nygaard and Mareile Wolff
Norwegian Meteorological Institute, Observation Department
P.O. Box 43 Blindern, NO – 0313 OSLO, Norway
Phone: +47 22 96 30 00, Fax: +47 22 96 30 50, e-mail: hildegunn.nygaard@met.no

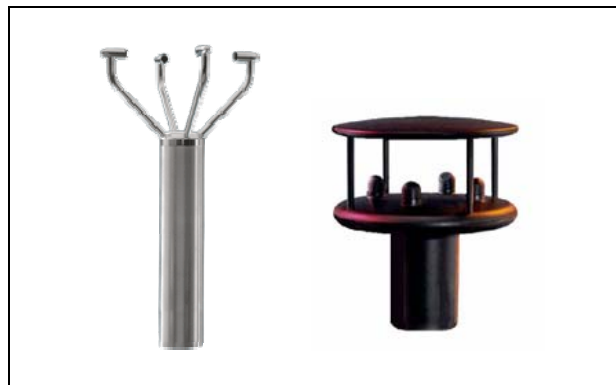
Figure 1: Gill WindObserver II (with de-icing system) to the left and Gill WindSonic (without heating) to the right.

The purpose of this study was to evaluate the reliability of the ultrasonic sensors in the Norwegian weather station network, and to test their performance during the winter season, especially at places where instruments encounter icing-problems. The Gill WindObserver II is equipped with a de-icing system, whereas the Gill WindSonic works without any heating. The WindSonic sensors are used at solar/battery powered stations in Norway.

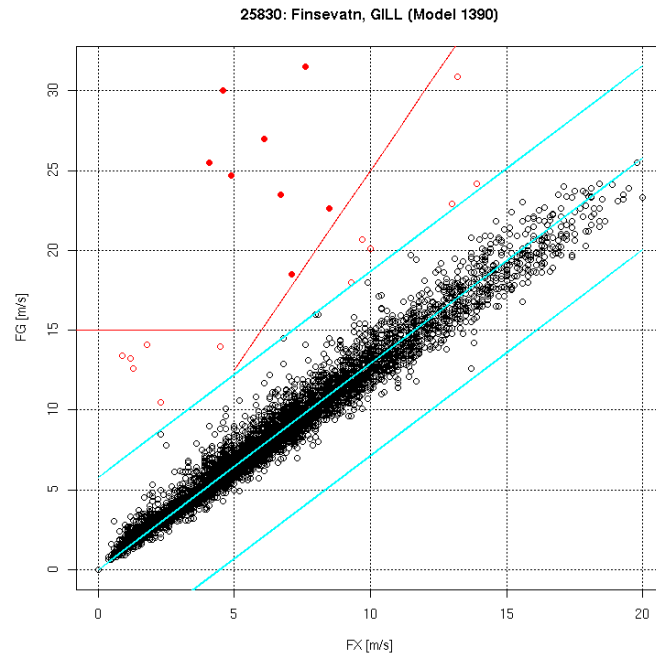
Figure 2: Scatter plot, maximum gust (FG) versus maximum wind speed (FX) for Finsevatn station (1210 m.a.s.l). Linear regression line with 5 times its standard deviation (blue lines) and $FG = 2.5 \cdot FX$ (red line). Red marks indicate outliers.

Finsevatn (1210 m.a.s.l. in Southern Norway) showed large gust values in two cases during autumn/winter 2009 (Figure 2 and 3). In both cases the temperature was below 0 °C and the humidity was high. This is a typical situation where riming occurs. Finsevatn is located nearby a river and the area is known for sudden occurrence of frost and rime especially during autumns.

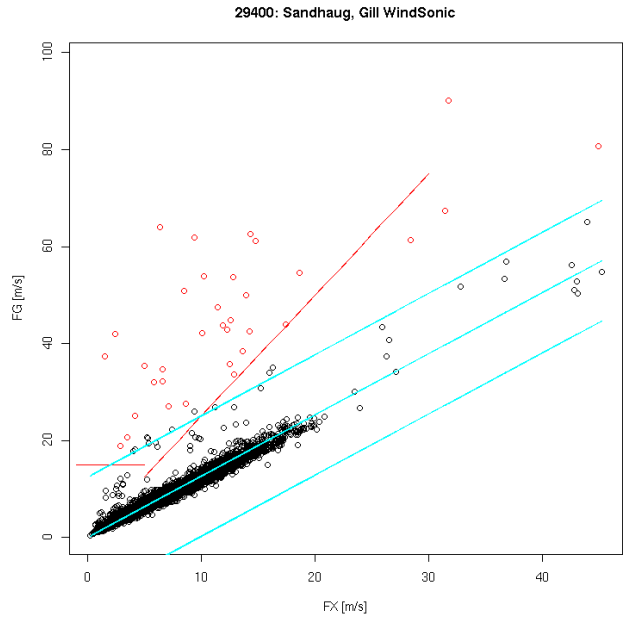
Figure 7: Scatter plot of maximum gust (FG) versus maximum wind speed (FX) at Sandhaug (1250 m.a.s.l in Southern Norway). Linear regression line with 5 times its standard deviation (blue lines) and $FG = 2.5 \cdot FX$ (red line). Outliers are marked with red circles.

Sandhaug is situated 1250 m.a.s.l. in the mountains in southern Norway. This station has additional wind measurements with a mechanical Young wind sensor. The observation record of the Gill WindSonic shows very high gust values (outliers) in two periods during autumn 2009 (Figure 7 and 9). Surrounding stations measured heavy precipitation, and the temperature was below 0 °C during these periods (Figure 8). Occasionally, data also dropped out.

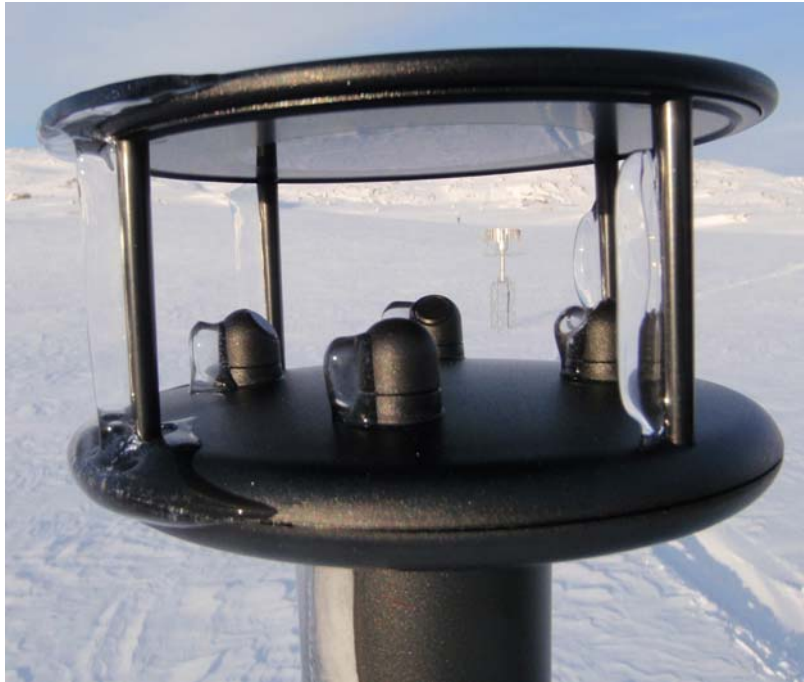
Figure 12: Gill WindSonic with icing. Data from this test site is not included in this study.

Gill WindSonic is not suitable for use in areas with low temperatures due to risk of icing. Figure 12 illustrates this. The sensor shown in the picture is mounted on a test station that is not included in this study. It also seems that this type of sensor occasionally show unrealistically high gust values in heavy snow and sleet. Data also drop out in such situations. But Gill WindSonic is suitable at weather stations with minimal risk of icing and rarely heavy snow and sleet. This sensor is only in use at solar/battery powered stations in the Norwegian station network.
