INTERCOMPARISON OF WINTER PERFORMANCE OF RAIN GAUGES

Abstract

The network of Automatic Weather Station (AWS) operated by the Austrian Central Institute for Meteorology and Geodynamics (ZAMG) will be extended with 50 new AWS in the next two years. Because most of the AWS are situated in mountainous regions the selection of an appropriate sensor systems for precipitation measurement offering reliable winter operation is required.

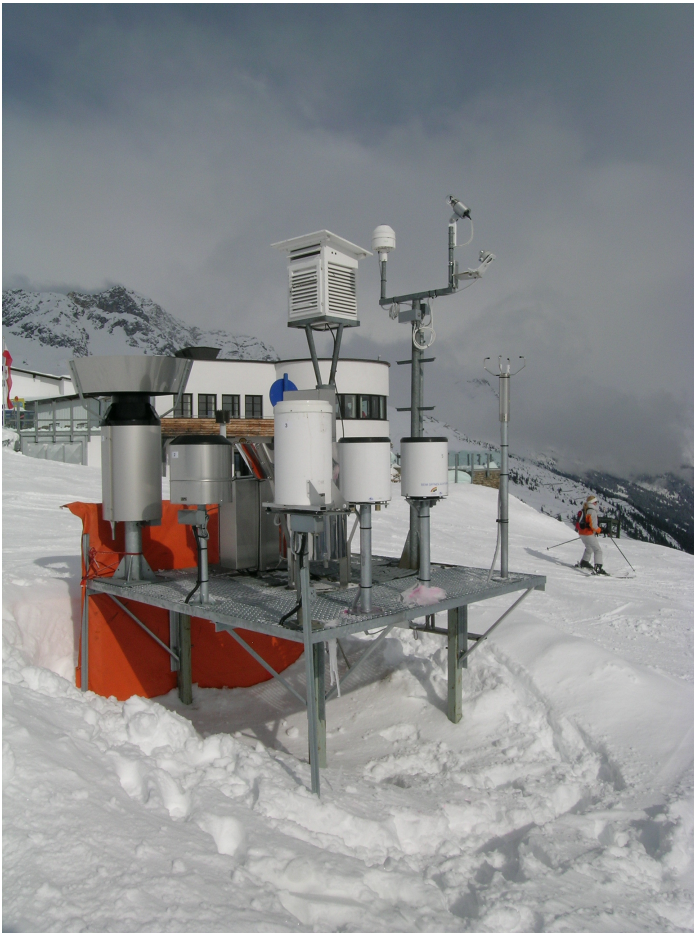
Figure 1: Test platform at Galzig
Test instruments

from the left to the right:

- Sommer NIWA MED K505
- MPS TRWS
- Paar AP23
- Meteoservis/Kroneis MR3H
- Meteoservis MR3H-F

The test site for the winter performance test of rain gauges is situated at Galzig in Western Austria at 2085 above sea-level in the Arlberg region, where we often have severe weather conditions with low temperature rime and frost accretion in combination with high wind speed (Figure 1). Unfortunately there is not enough space for installing rain gauges according [3]. On the limited space of the existing test platform (about 2,5 x 2,5m) beside the various test instruments are also installed the instruments of the standard Automatic Weather Station. Therefore the precipitation measurement of all instruments is expected to be highly influenced by the surrounding constructions. We have to expect differences in precipitation reported by different instruments installed side by side in the order of more than 200%. Nevertheless malfunction or failure of the instruments can be proved.

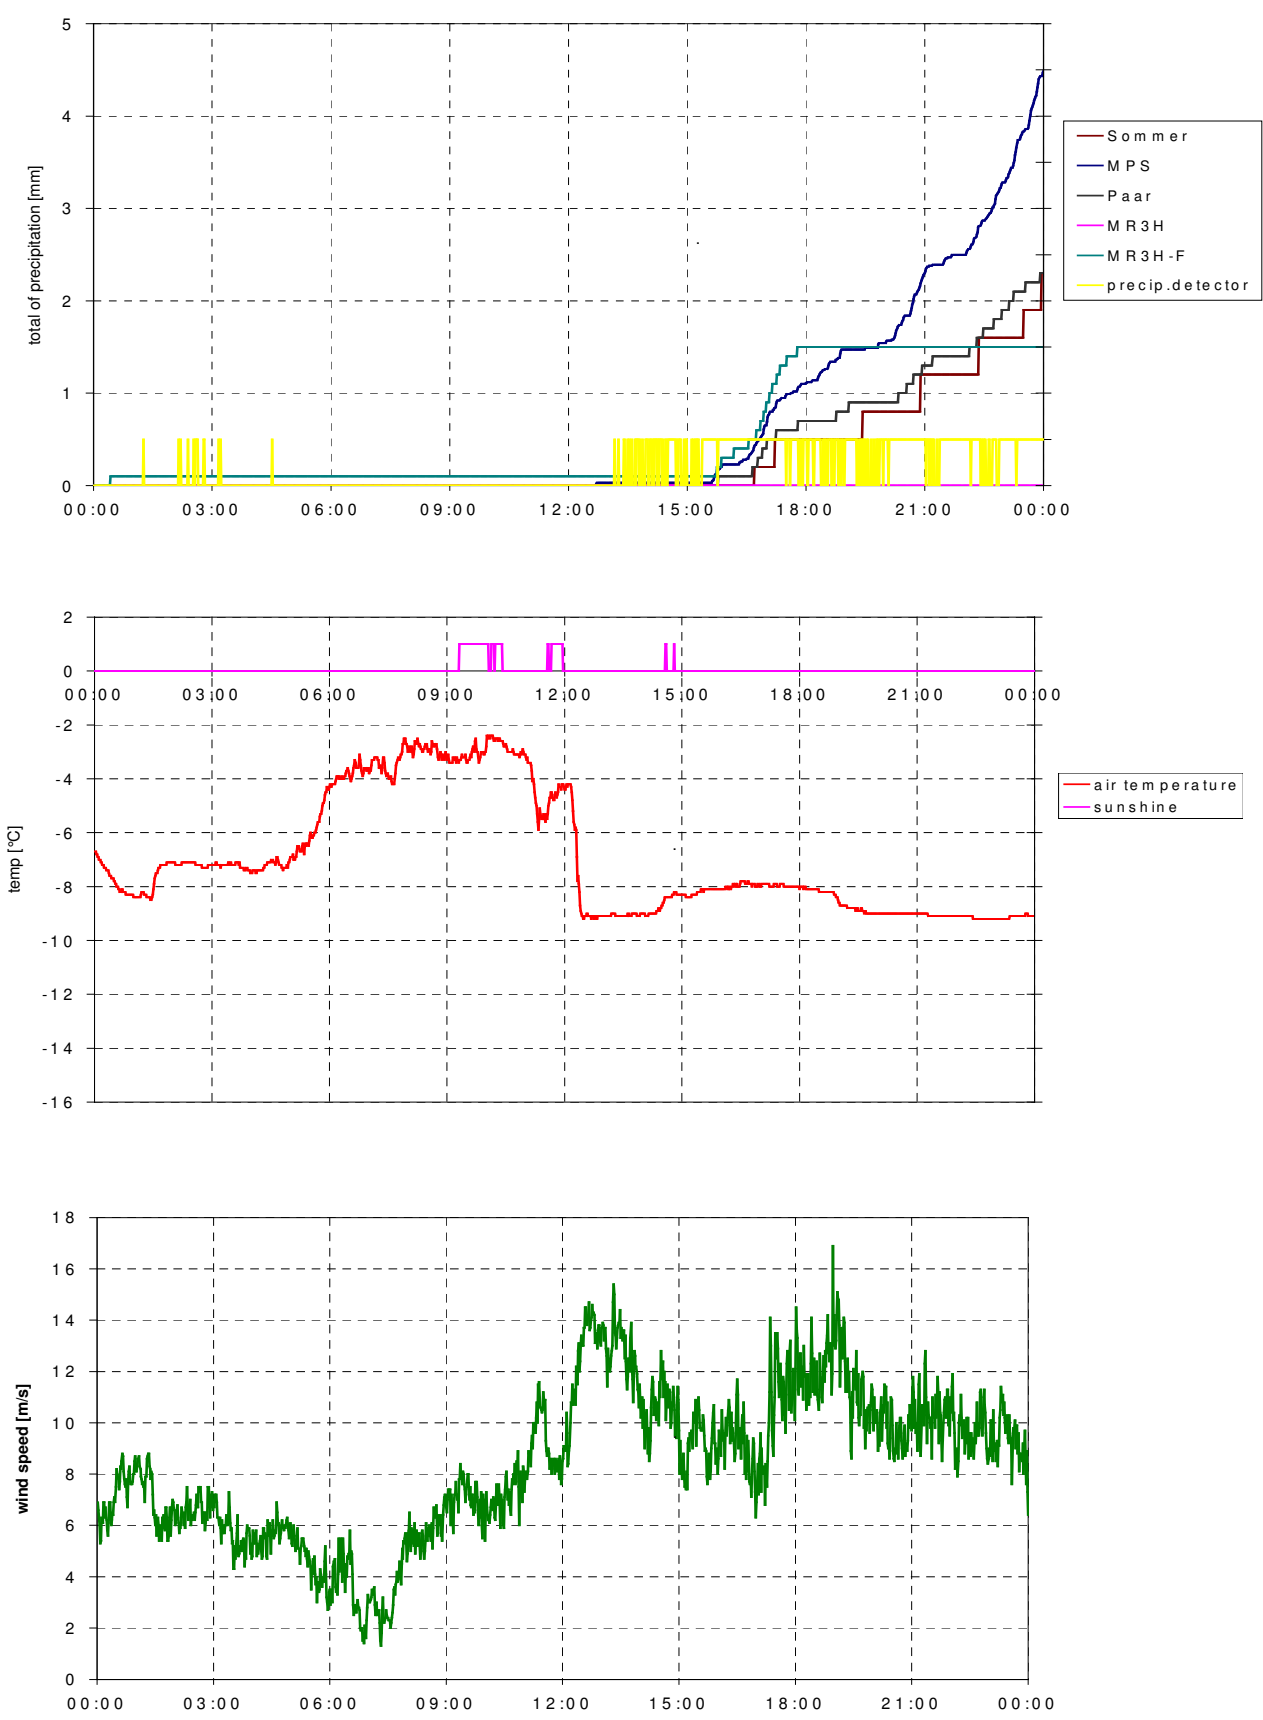
Figure 4: Precipitation, wind speed, air temperature and sunshine detector on 08.02.2006. Sommer NIWA-Med K505 reports non realistic intensities, but correct sum of precipitation.

The monthly sum of precipitation (Figure 2) is close to the precipitation reported by the Paar AP23 standard tipping bucket gauge, but the number of failure events in total is more than twice as high. The failure of this instrument is caused generally by delayed output of measurement data (up to 30 minutes) depending on wind speed (see Figure 4). This effect caused by software filtering of wind induced vibration effects very often causes non realistic precipitation intensities (overestimation up to factor 4). Nevertheless the total amount of precipitation reported by this instrument comes close to the standard gauge.

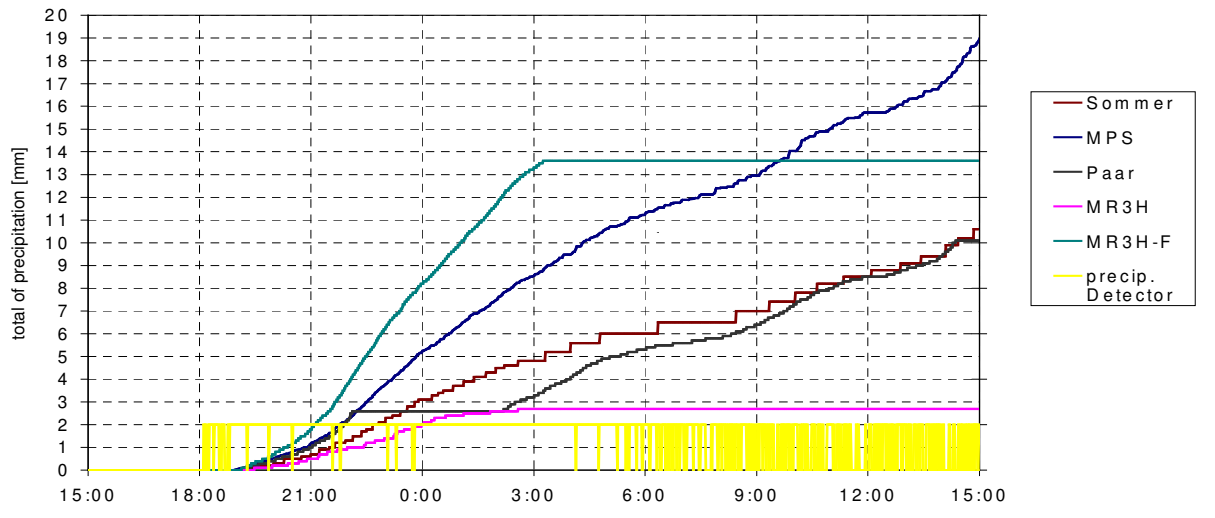
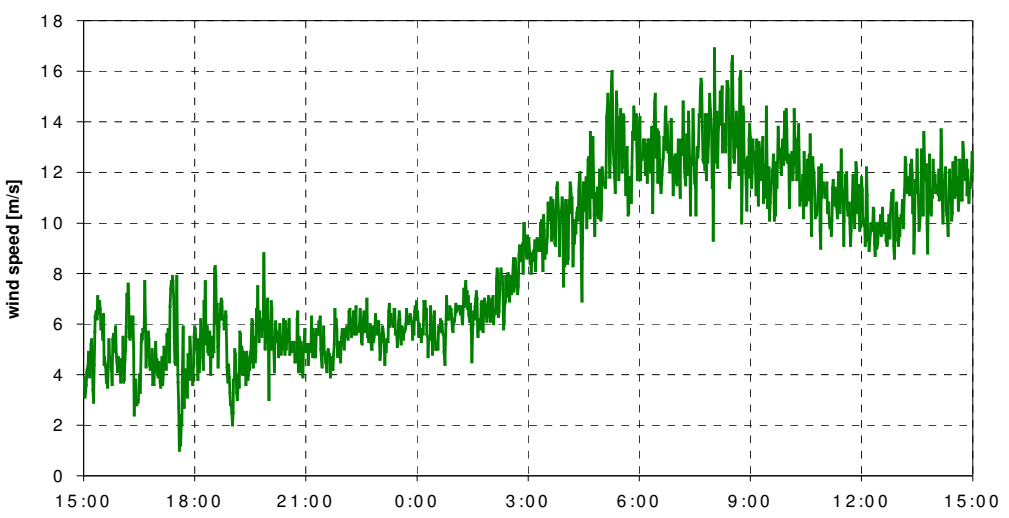
Figure 6: Precipitation, wind speed, air temperature and sunshine detector 17.01.2006 15:00 to 18.01.2006 15:00. Failure and blocking effects on all tipping bucket gauges.

This effect is visible on the example shown in Figure 6. At 3:00 the instrument is blocked with noticeable overestimation of precipitation in the period before the blockage occurs. In Figure 8a the effect of icing below the instrument is shown.

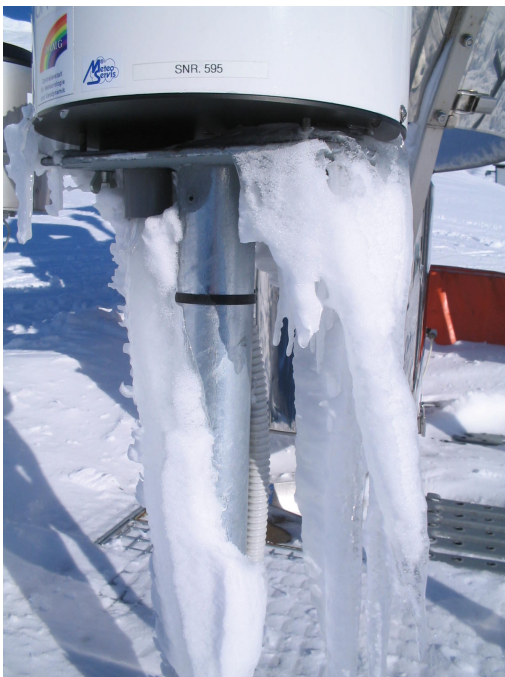
Figure 8: a) Icing on the outflow of METEOSERVIS MR3H-F(old)
 b) Improved version of METEOSERVIS MR3H-F(new) with additional outflow heating

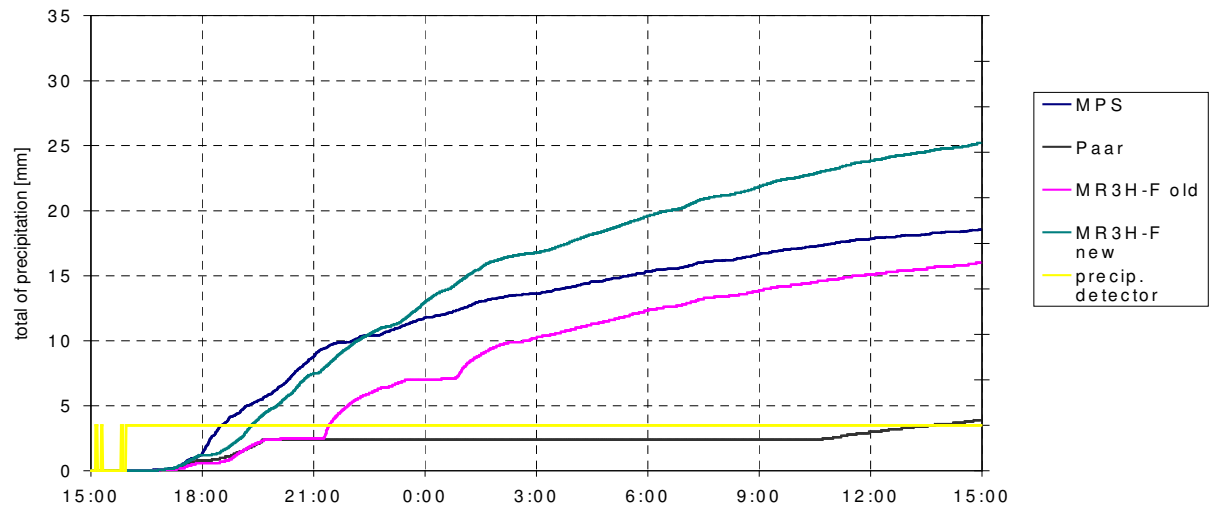
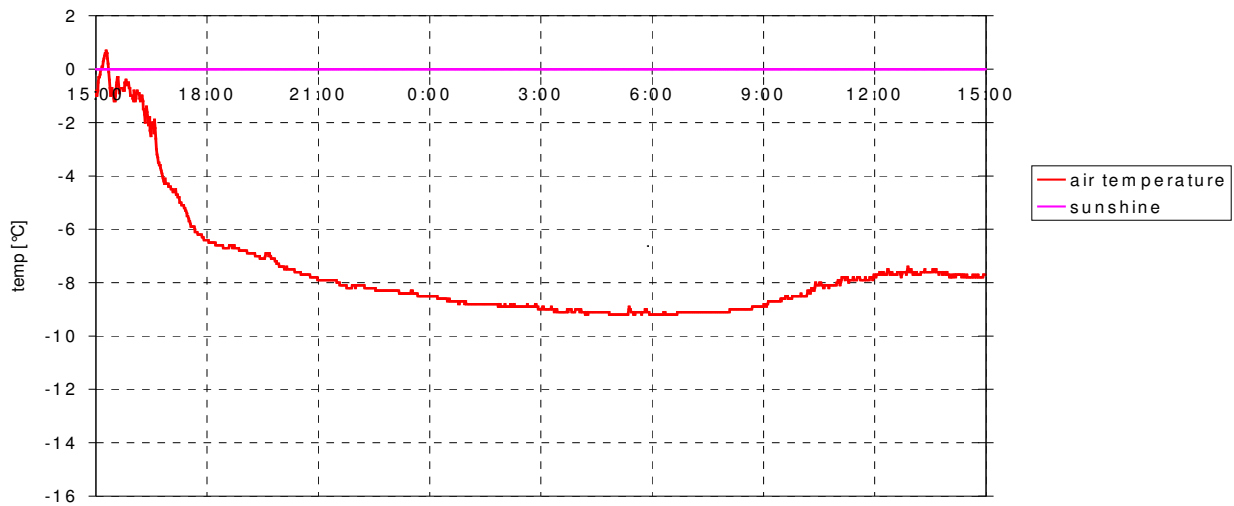
Figure 9: Precipitation, wind speed, air temperature and sunshine detector 10.04.2006 15:00 to 11.04.2006 15:00. Failure and temporary blocking effects on all tipping bucket gauges except MR3H-F(new)

In Figure 9 the improvement is evident: the MR3H-F(new) is working properly the whole period of time whereas the previous standard version MR3H-F(old) is blocked for several hours, similar to Paar AP23.
