Mooring Modifications for the Reduction of Losses to Vandalism

Technical and Scientific Workshop

Data Buoy Cooperation Panel

Mooring Vandalism

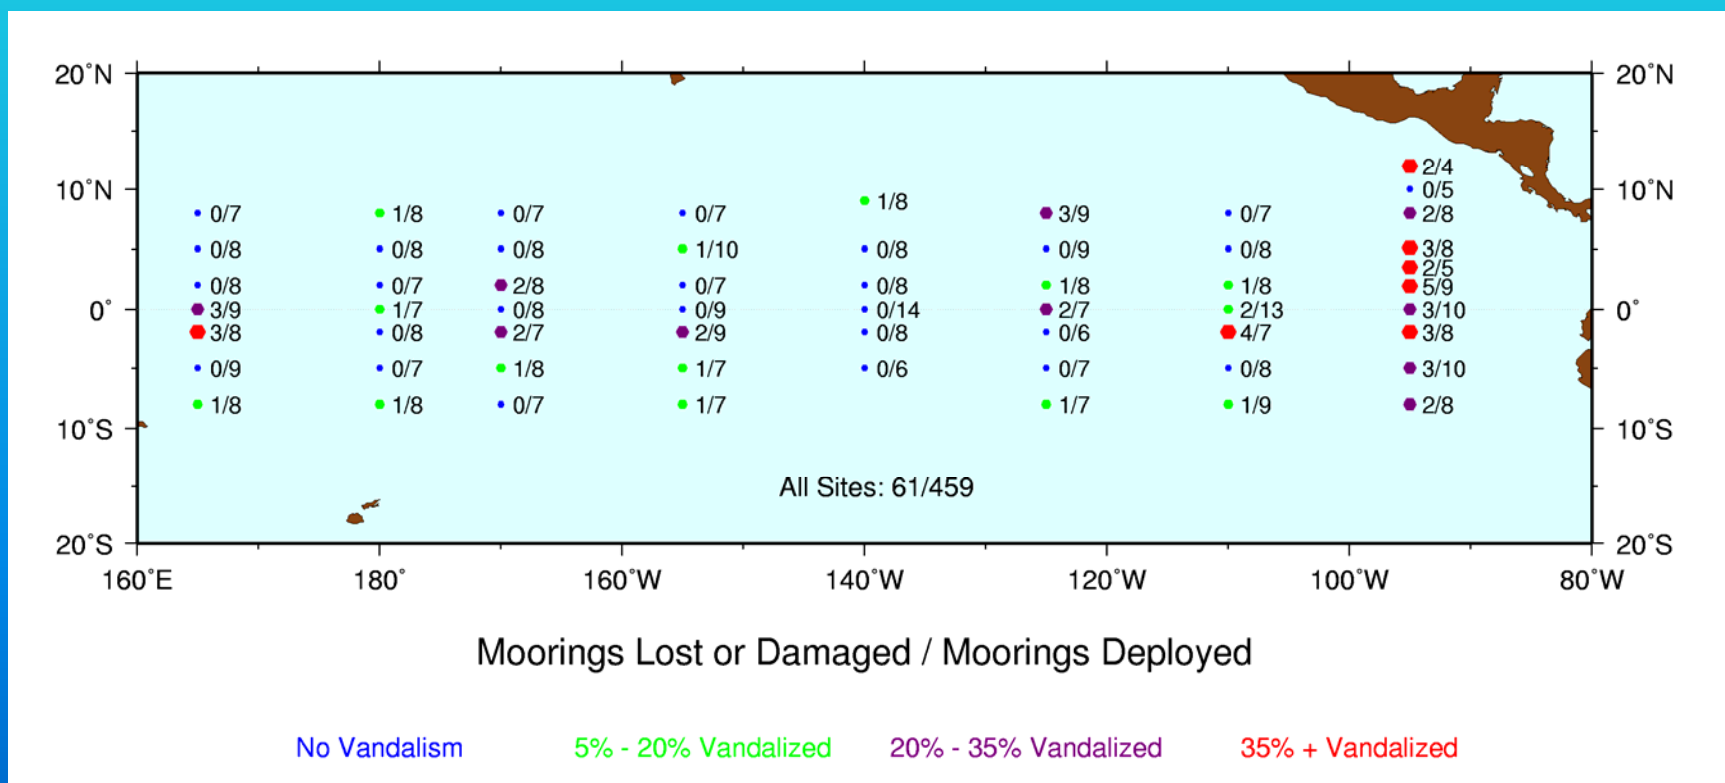
Major TAO Vandalism 2000-2007

Moorings which were entirely lost, or all surface or subsurface sensors were lost.

Majority of major vandalism was mainly in eastern portion of the Pacific Basin.

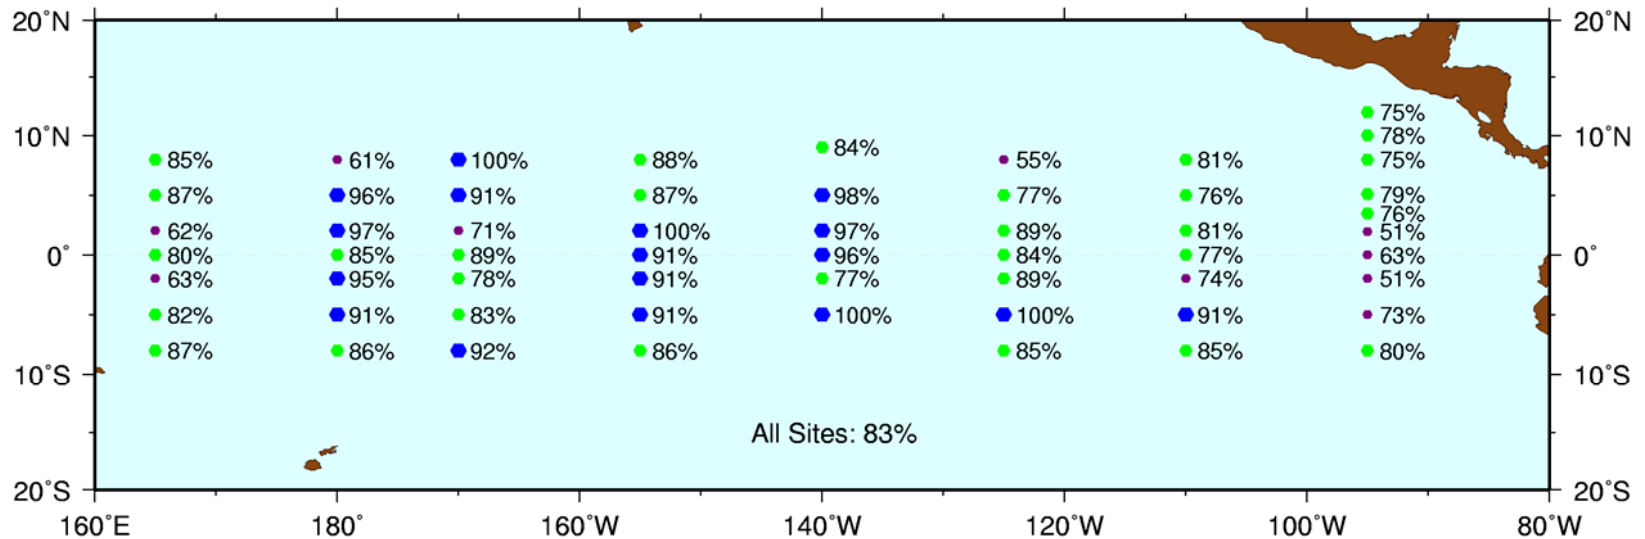
January 2000 - June 2007

- Wind sensor is one of the most often vandalized.
- Pattern of data loss is consistent with pattern of vandalism.
- Data return for all standard sensors was 91%.
