Hopa Flash Flood Event

24 August 2015

Yusuf ULUPINAR

Turkish State Meteorological Service
yulupinar@mgm.gov.tr

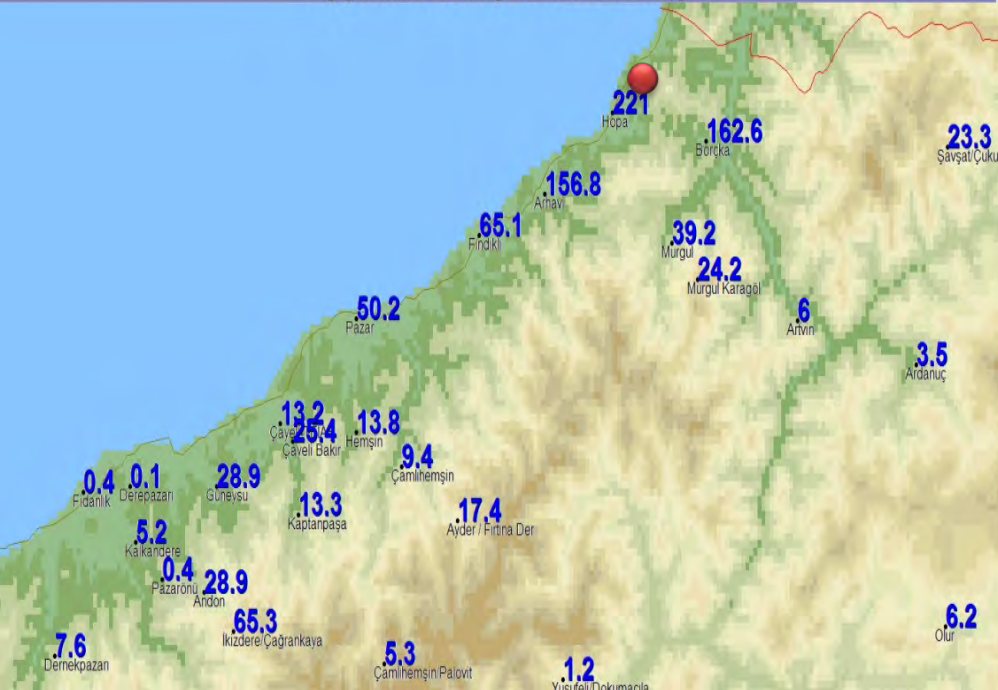
Yağış Miktarı 24saat | 25/08/2015 06 Gmt |

- Hopa town is located in northeast of Turkey on the Black Sea Coast.
- Eastern Black Sea region has the highest annual rainfall accumulation Turkey. It is over 2000 mm.
- 24 h precipitation accumulation 25 .08.2015 at 06 UTC is shown on the image.

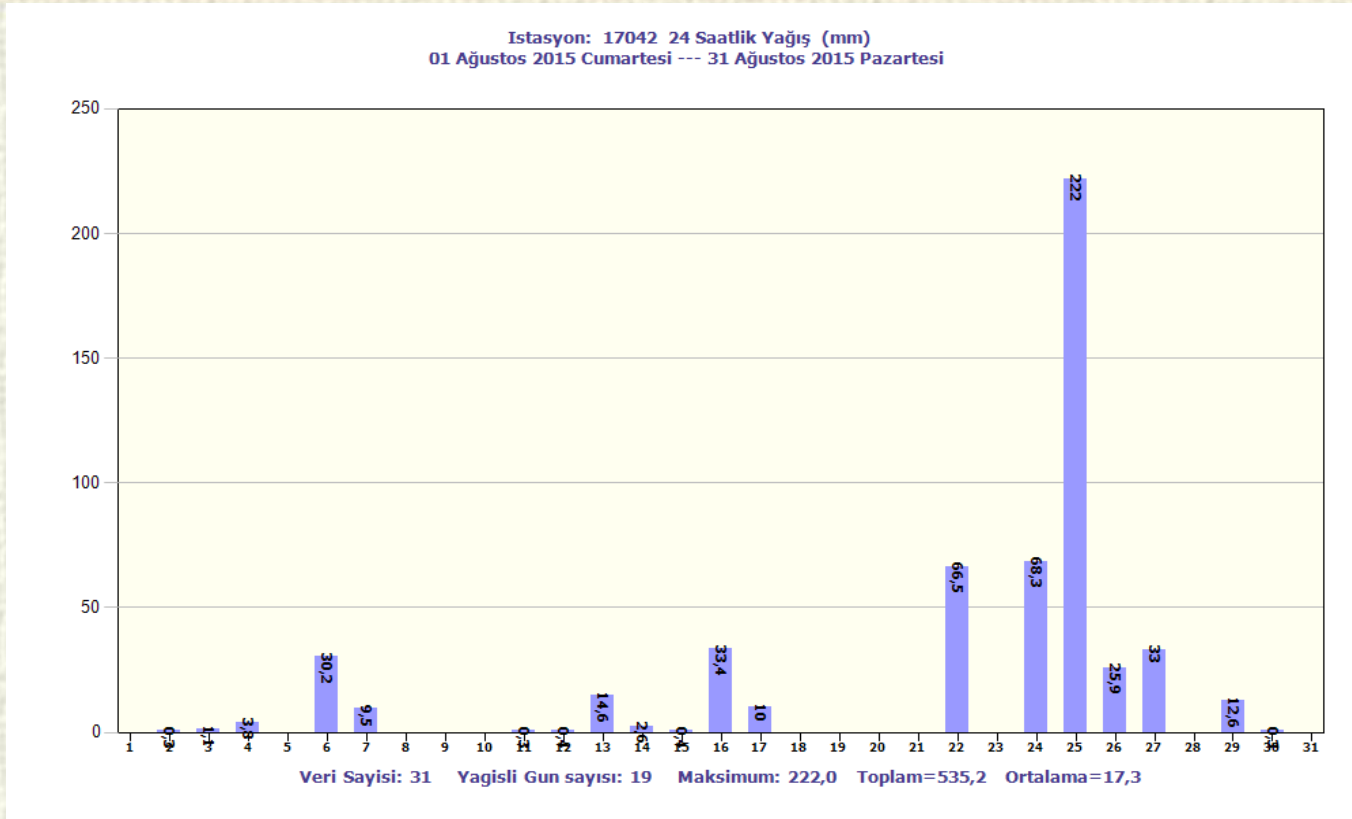
Daily Precipitation Accumulation

- Daily precipitation accumulation is shown in the above Figure that, on August 25th, it was of 221 mm.

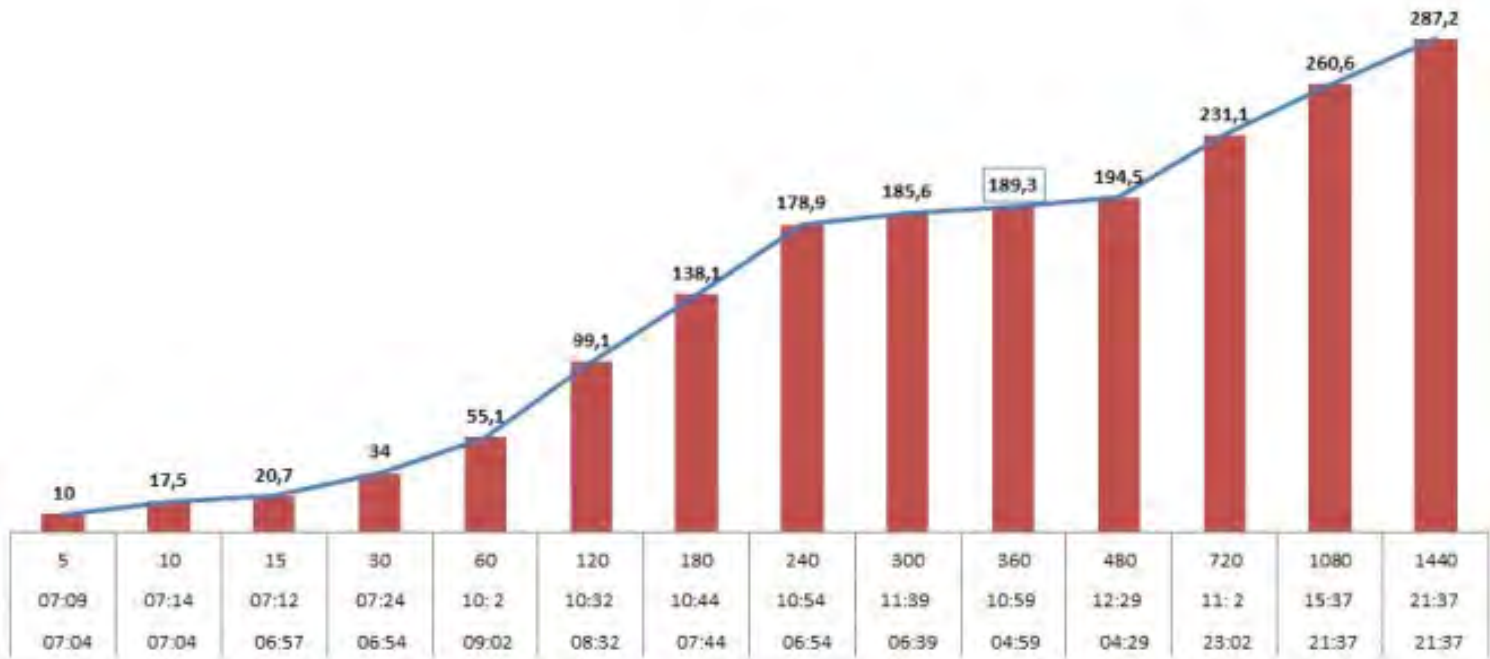
Hopa Standart zamanlardaki yağış şiddeti 23-24 Ağustos 2015

➤ The measured precipitation data were the extrem values for the period of 1965-2015.

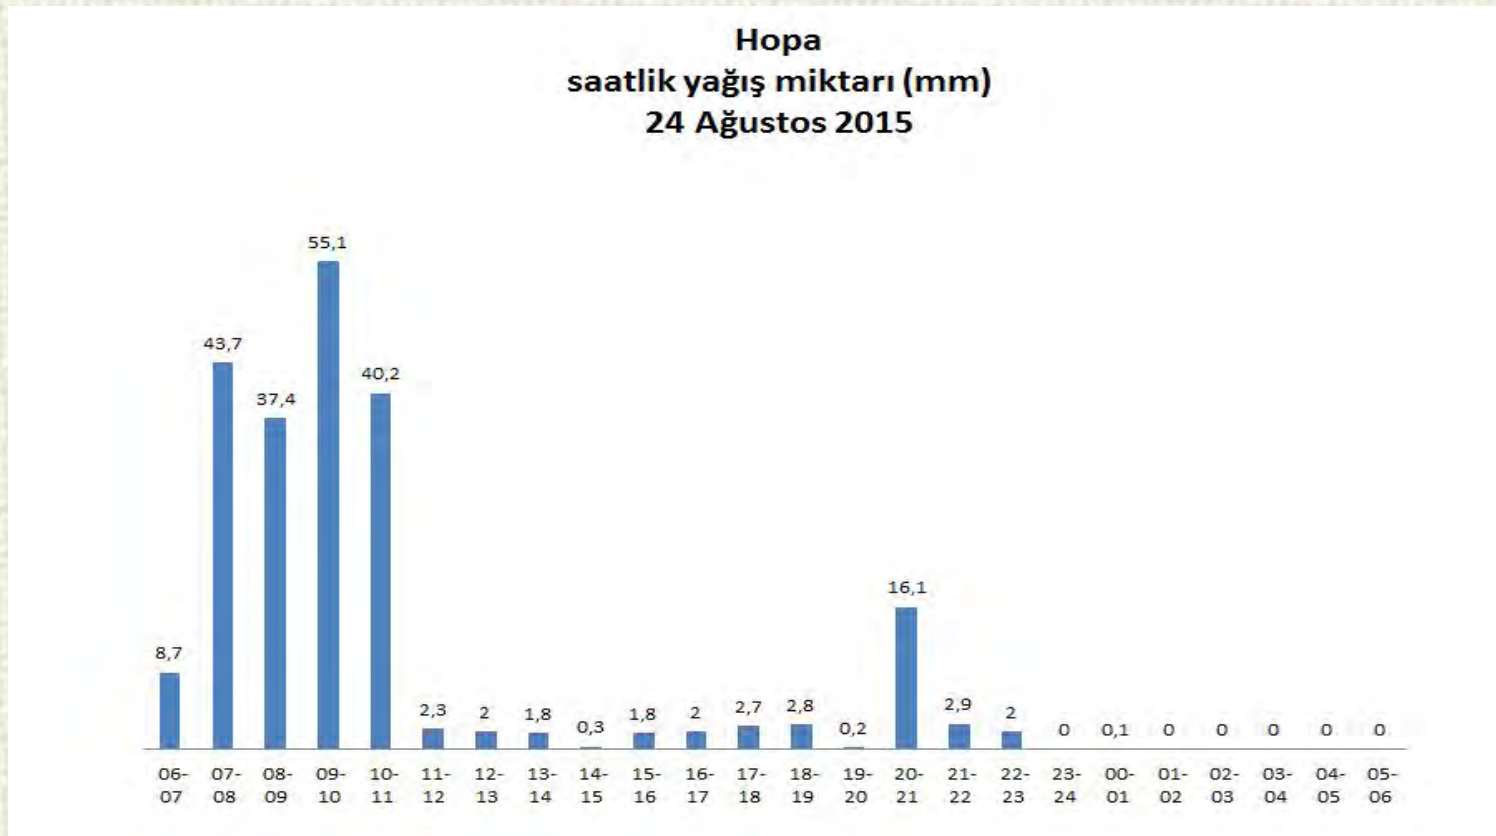
➤ Rainfall intensity graph shows that heavy precipitation lasted for 4 hours from 07-11 UTC with the values of 48.7, 37.4, 55.1 and 40.2 mm.

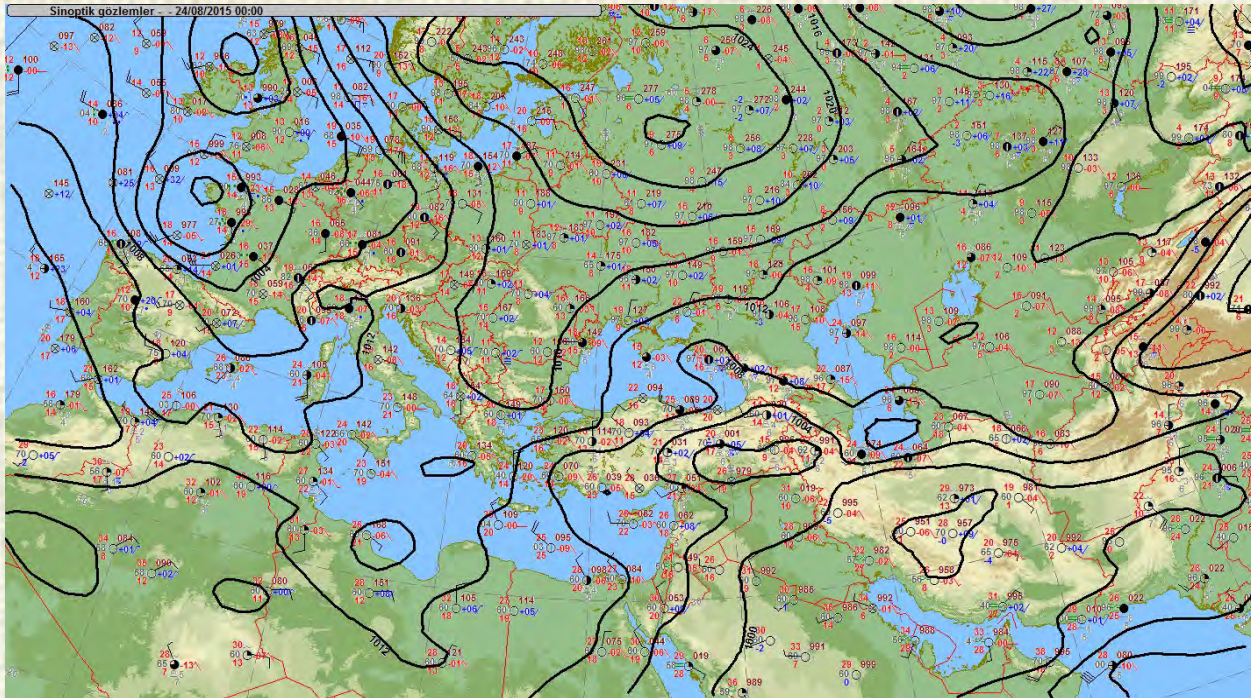
Synoptic Analysis-Surface Chart on August 24, 2015 00 UTC

- A low pressure center with a value 1000 hPa was located in the southeast region of the Turkey and ground pressure varies between 1010-1012 hPa. There is no significant pressure changes. Pressure has continuously rising trend during rains.

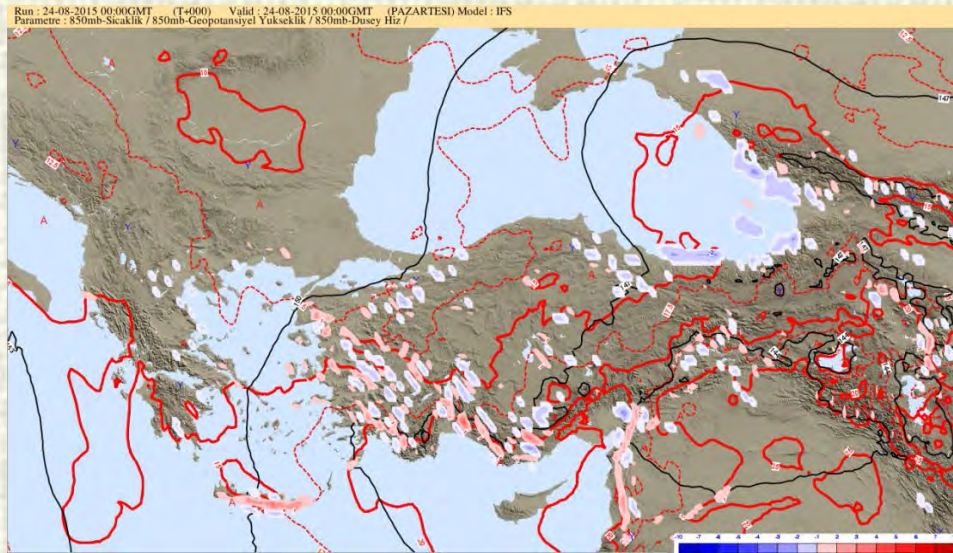
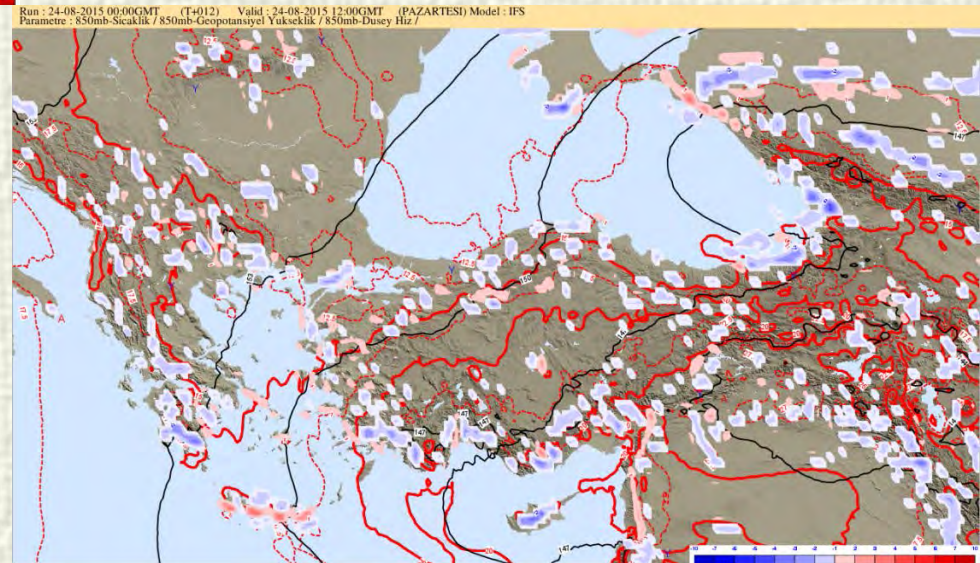
Synoptic Analysis -850 hPa on August 24, 2015

- 850 hPa geopotential height, vertical velocity and temperature values are shown on the 24th, August, at 00:00 UTC (left) and 12:00 UTC (bottom).
- There is a cyclonic circulation over the East Black Sea Region and cold advections behind of the cyclonic rotation.

- Low pressure center geopotential height is of 147 hPa. Isotherm value is of 15 ° C over the East Black Sea Coast.

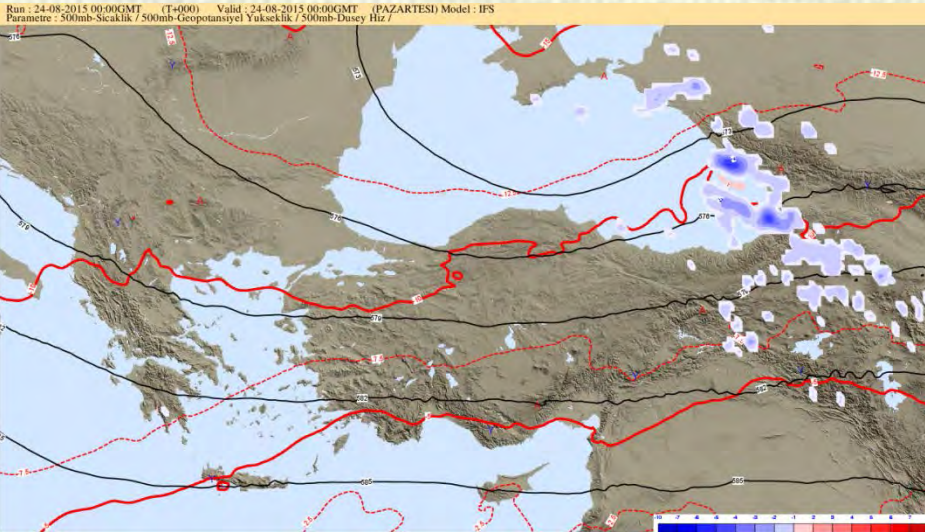
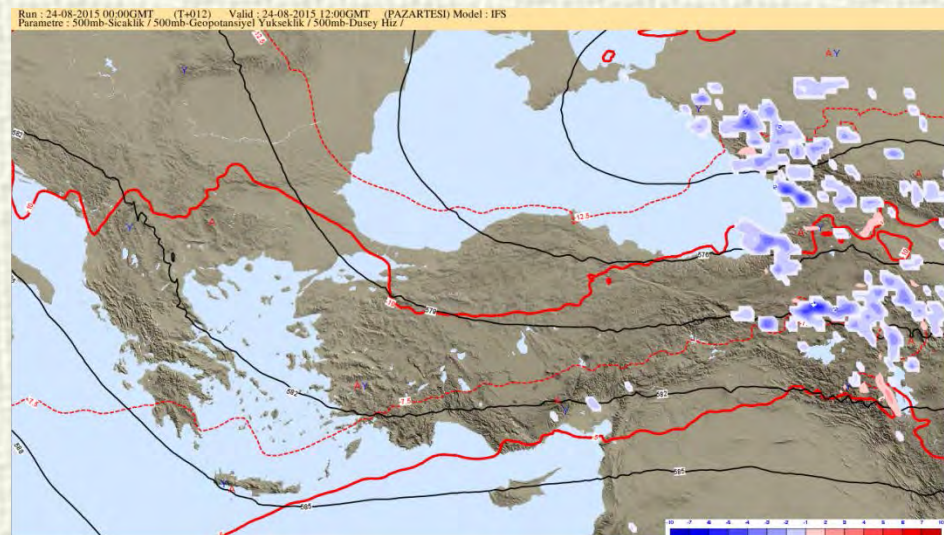
Synoptic Analysis- 500 hPa on August 24, 2015

➤ 500 hPa geopotential height and temperature values were shown on the 24th, August, at 00:00 UTC (left) and 12:00 UTC (bottom).

➤ There is south-western flow with cold trough in the north of the region at the 500 hPa level.

➤ Isotherm value is around -10°C over east Black Sea Coast and -17°C in the further north at the 500 hPa level.

➤ Slow movement of the low center here has provided continuity of heavy precipitation.

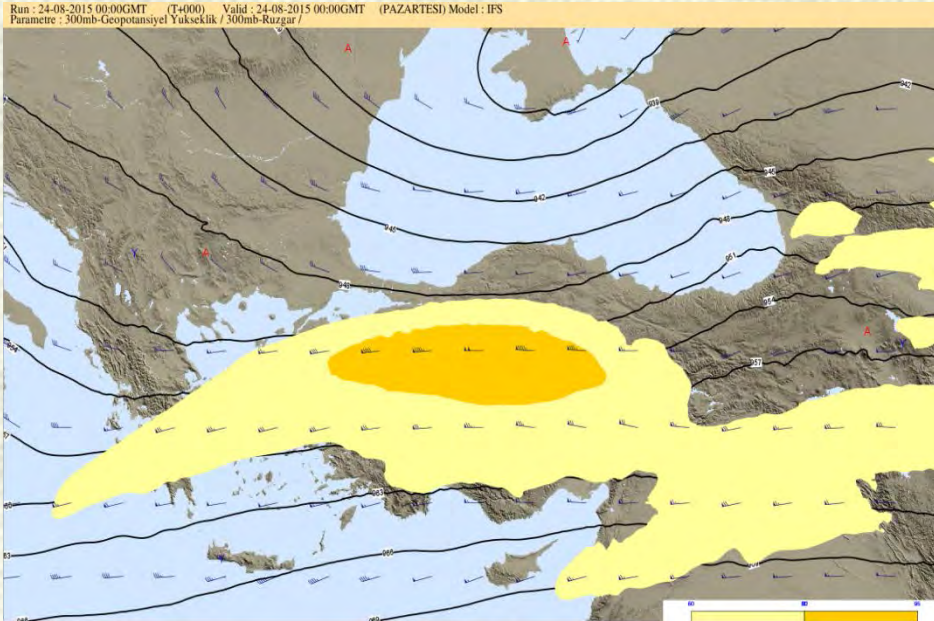
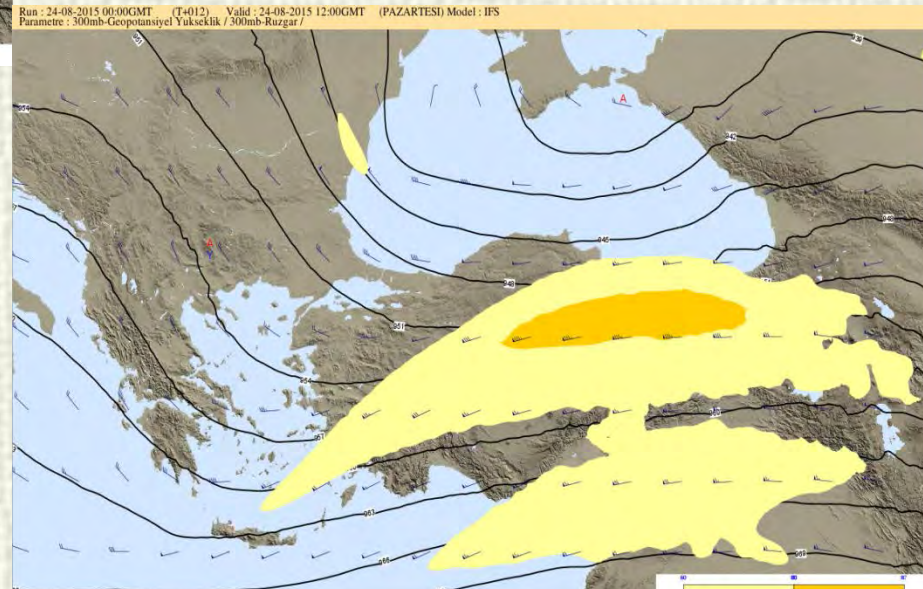
Jet Stream on August 24, 2015

➤ Jet stream exist in the middle Anatolia from Ege region to East Black Sea region having jet core wind speed of 100 knots (yellow).

➤ At 06:00 UTC (upper) and 12:00 UTC (bottom) 300 hPa maps show that jet core moved to the northeast and bringing warm air to East Black Sea region and make system of heavy rain move in the northeast direction.

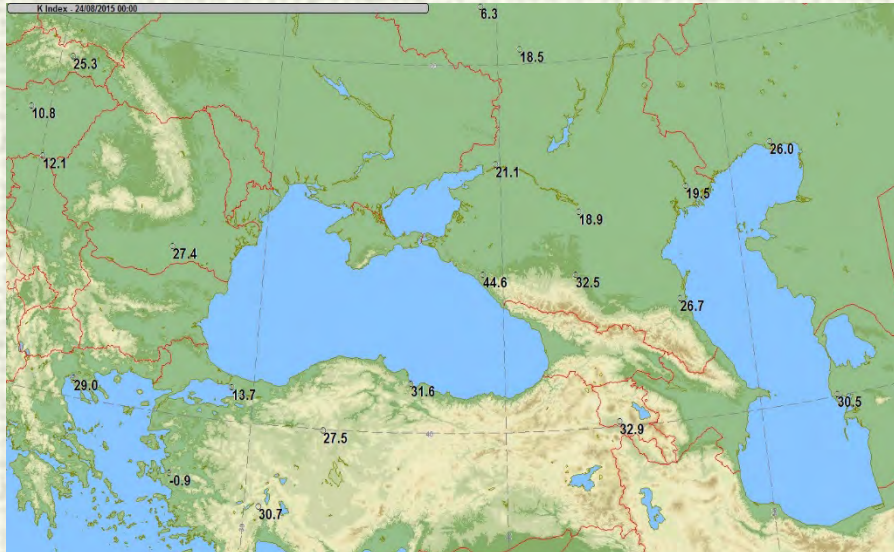
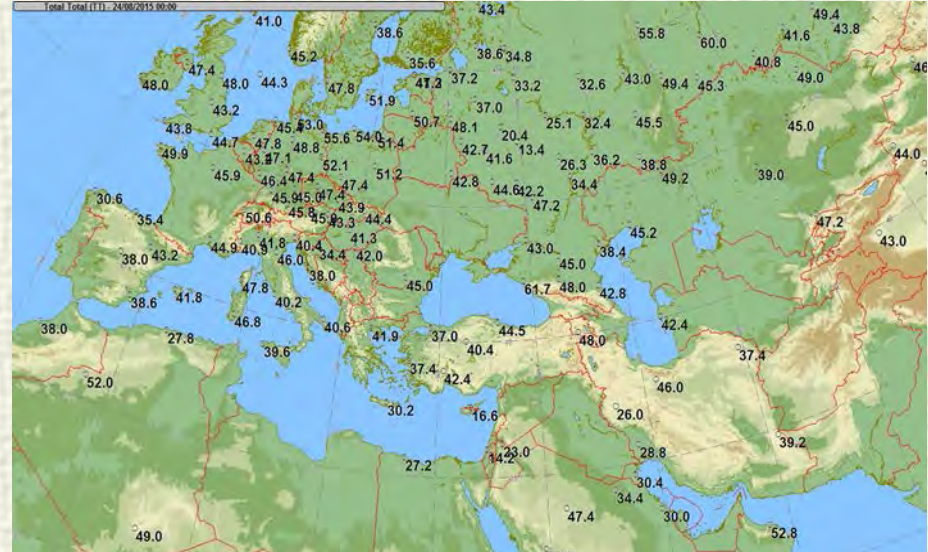
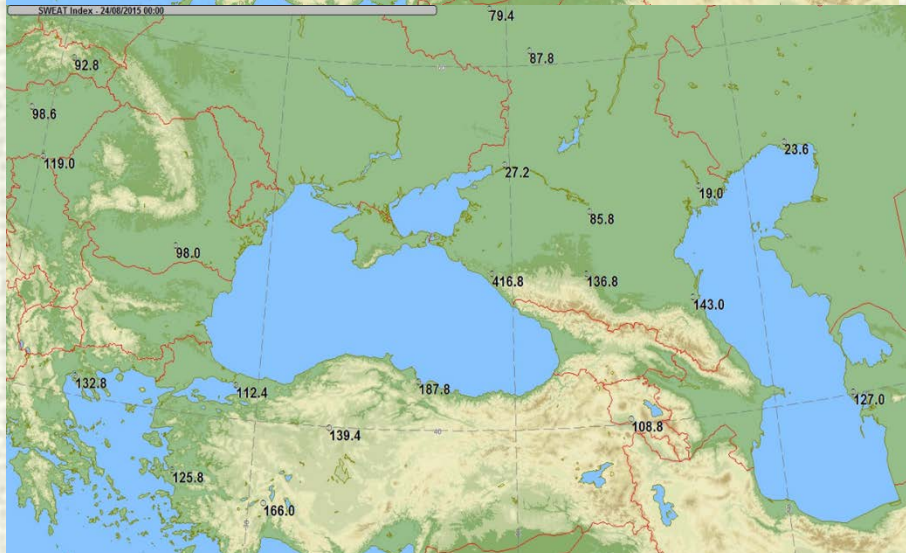
K, TT and Sweat Index on August 24, 2015 at 00

All index values are close to the extrem values.

➤ K index, TT index and Sweat index shows values 45, 62 and 425 respectively.

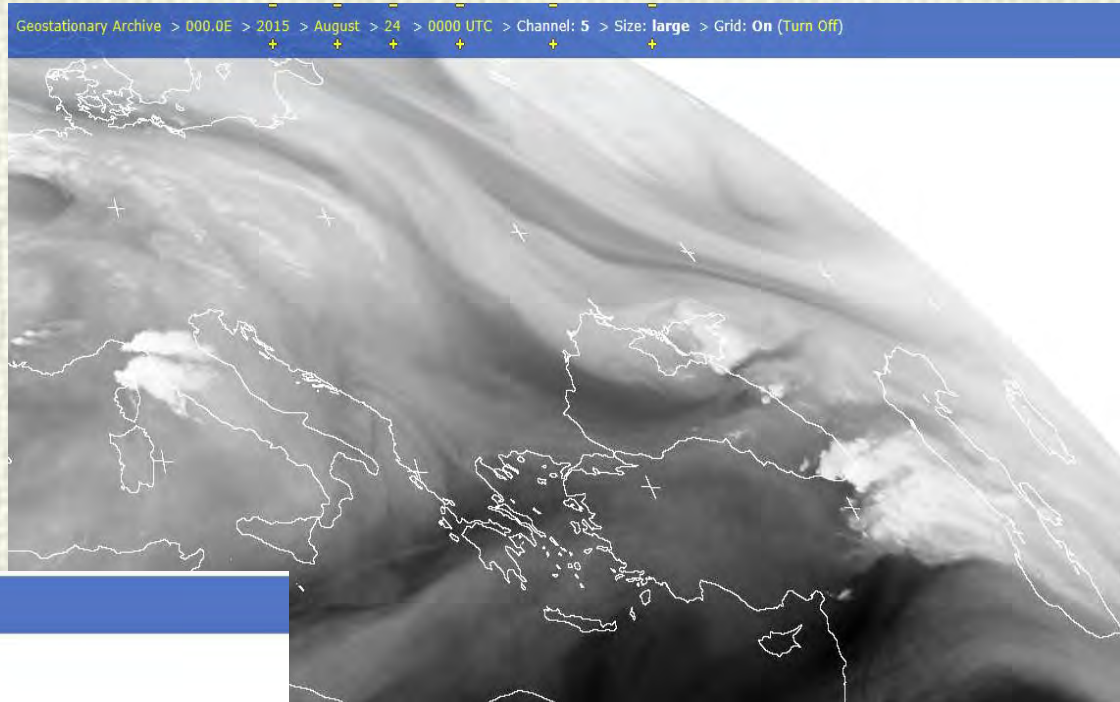
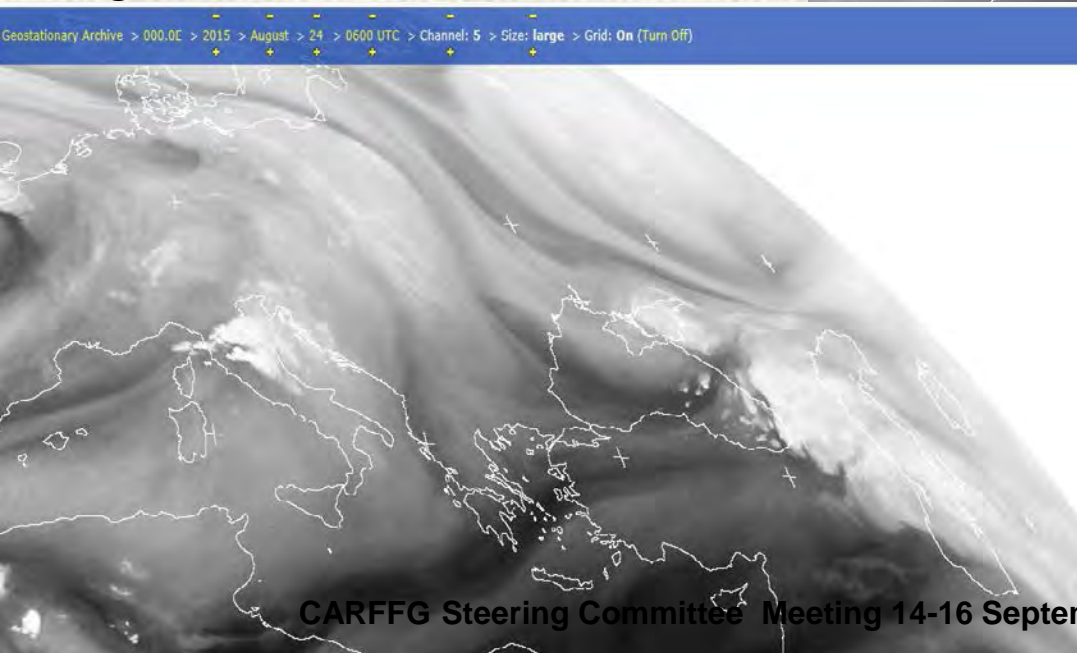
Satellite Images between 00:00-06:00 UTC on August 24, 2015

- Satellite images on 24.08.2015 at 00:00UTC (top) and at 06:00 UTC (bottom) show cloudiness over East Black Sea Coast in grey scale.
- It should be noted that Cb (Cumulonimbus) clouds that are associated with convection exist along the East Black Sea Coast that could be due to both frontal and orographical lifting.

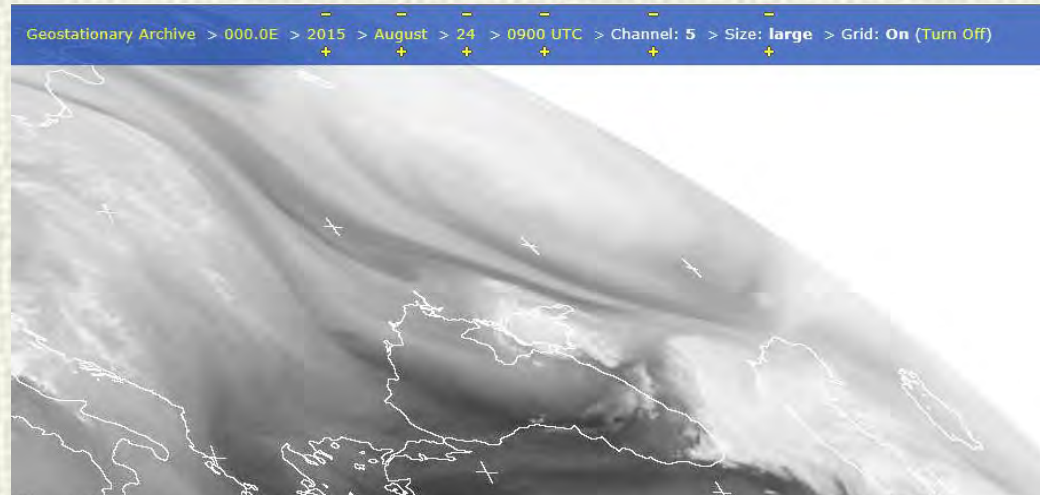
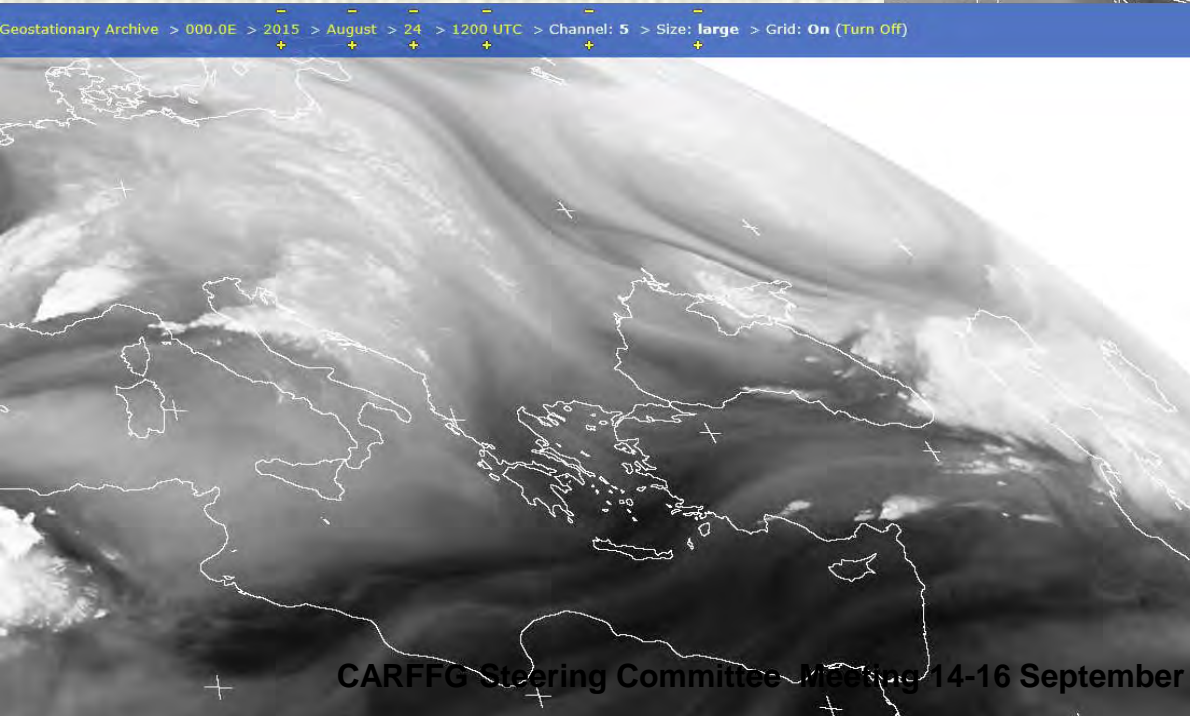
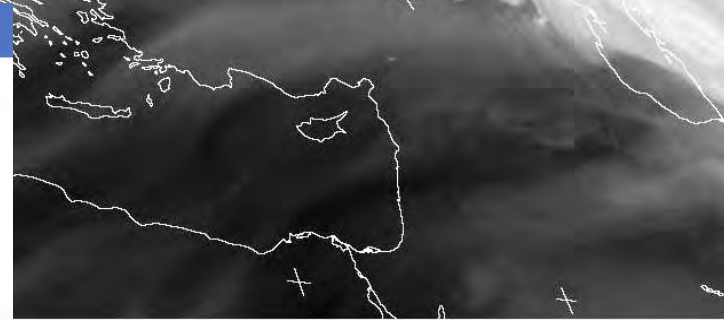
Satellite Images between 09:00-12:00 UTC on August 24, 2015

- Satellite images on 24.08.2014 at 09:00UTC (top) and at 12:00 UTC (bottom) show cloudiness over East Black Sea Coast in grey scale.
- It is clearly seen that cloudiness is moving in the direction of north east when compare with previous time.

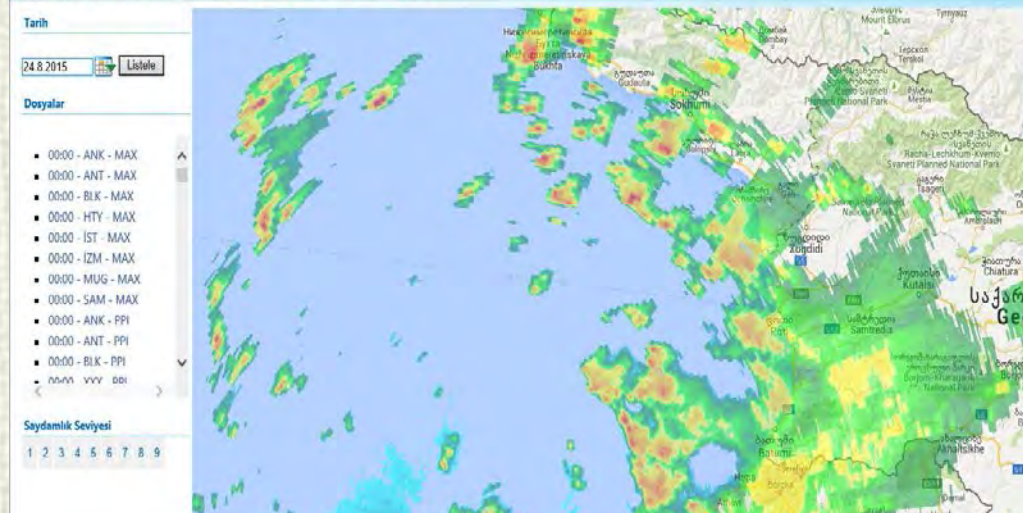
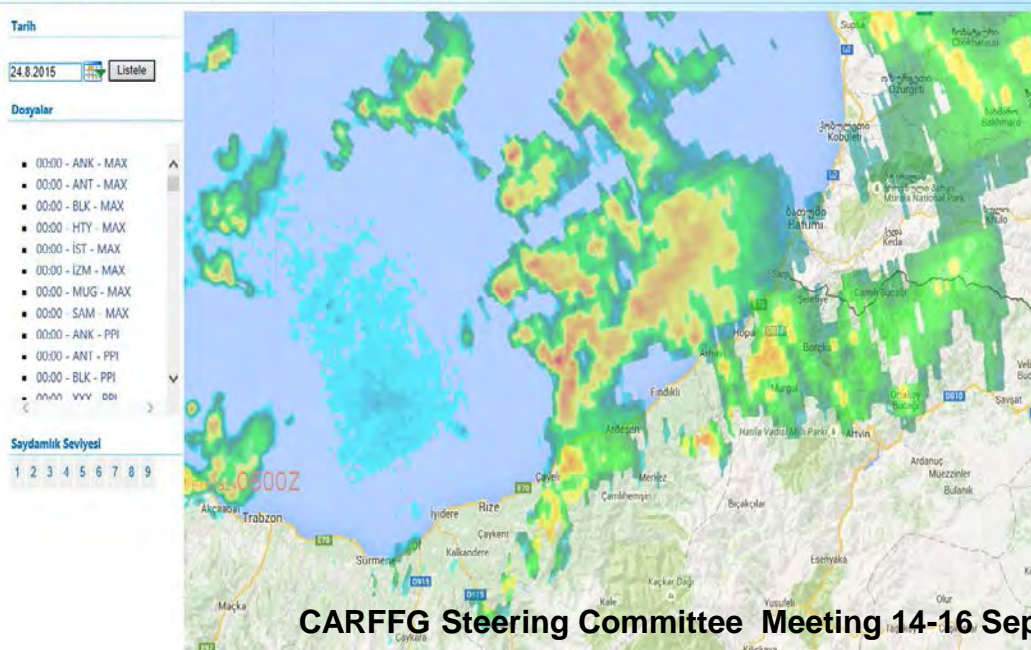
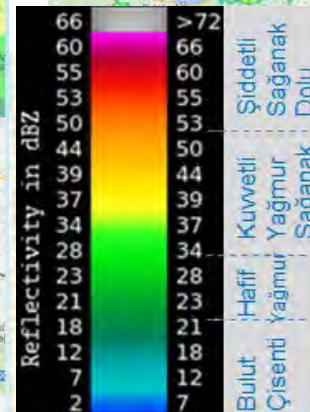
Radar Images at 03:00 and at 06:00 UTC on August 24, 2015

➤ PPI Radar images on 24.08.2014 at 03:00UTC (upper-right) and at 12:00 UTC (bottom-left) show density of the precipitation over East Black Sea Coast in colour scale at the bottom right.

➤ As seen in the 03:00 UTC and 06:00 UTC map, There is mostly yellow color along the region. That means, based on the scale, heavy rain shower.

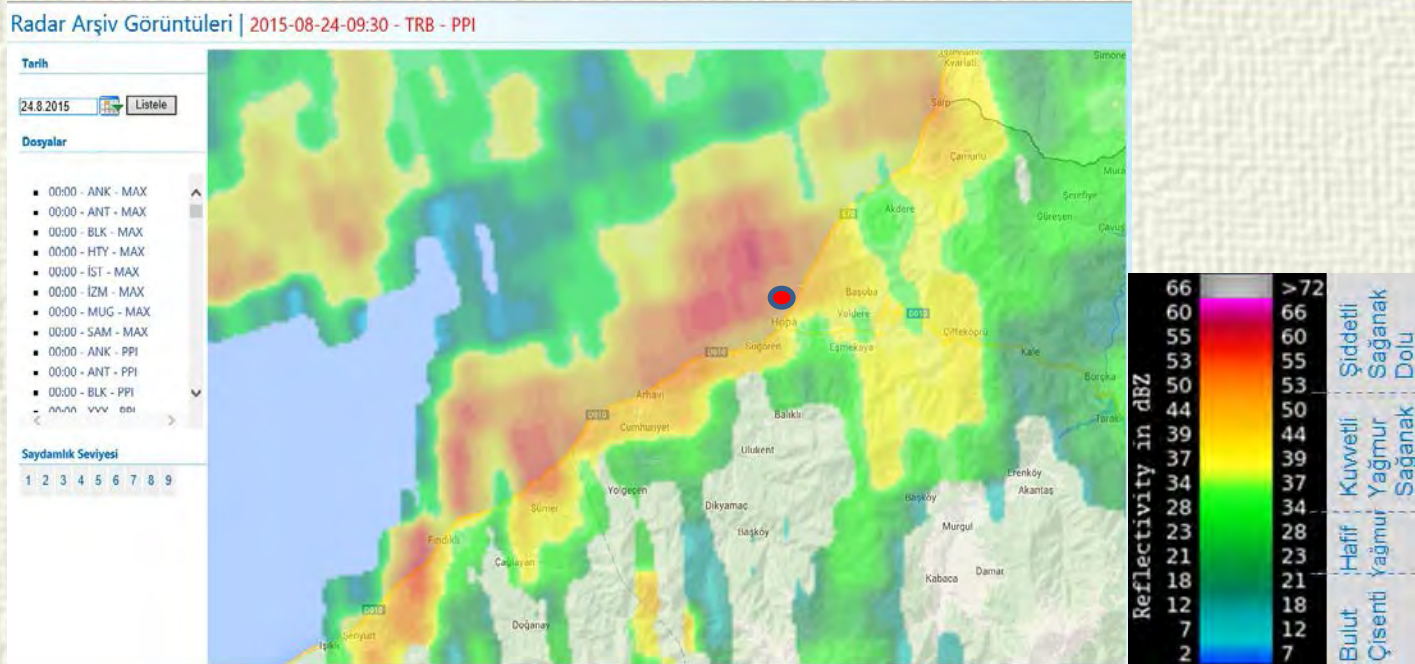
Radar Images at 09:30 UTC on August 24, 2015

- Along almost all East Black Sea is in colour that varying from yellow to dark red at 09:00 UTC Radar image. It means that severe thunderstorm and heavy rain shower continues along the coast based on the scale.
- Red dot on the map shows place in East Black Coast where rain shower is the most severe. That place is the Hopa district of the Artvin.

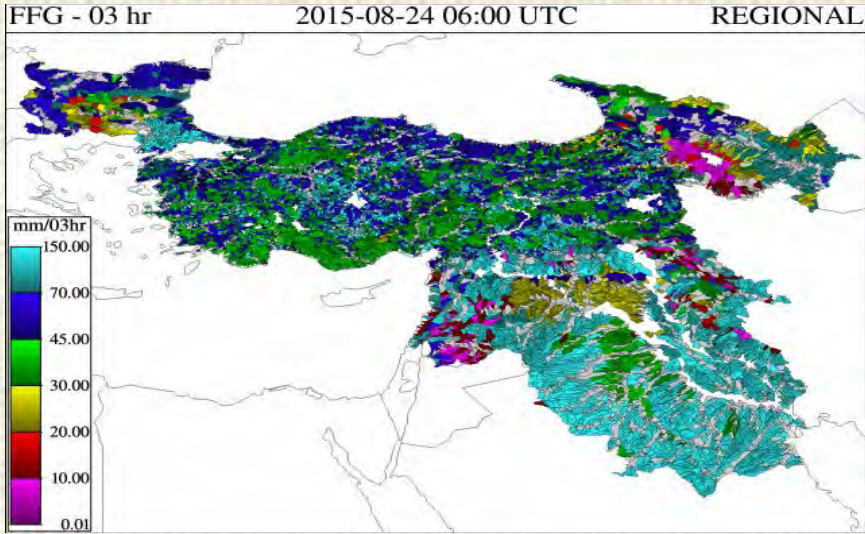
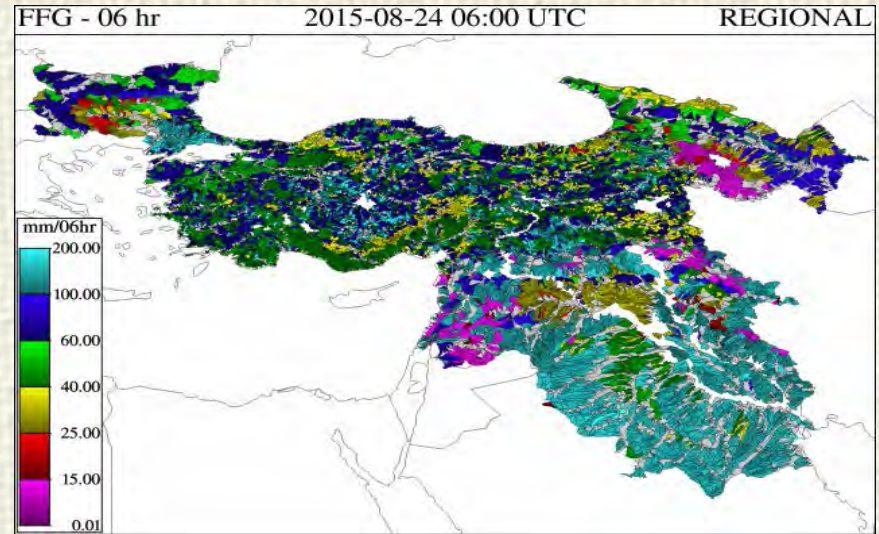
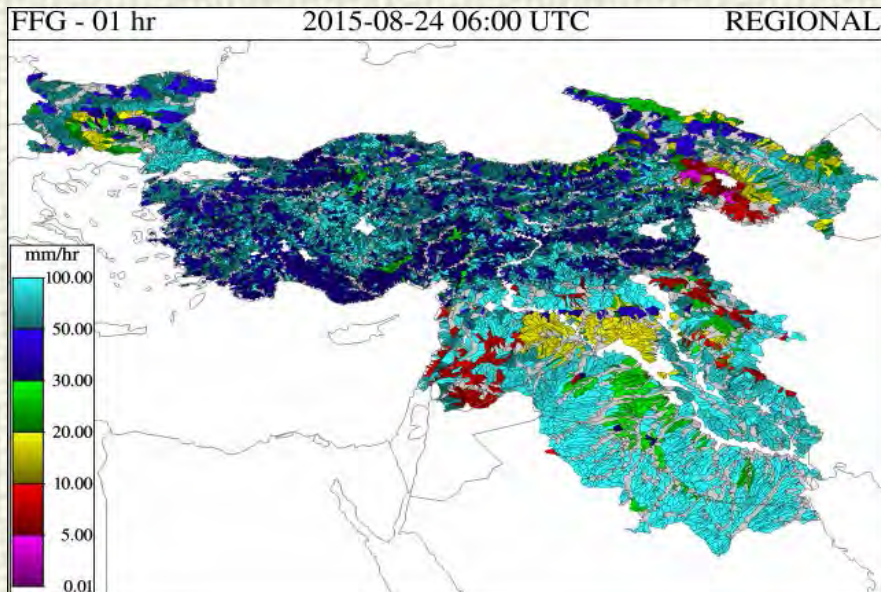
Flash Flood Guidance (FFG) is the actual rainfall that may cause just bankfull at the outlet of a sub-basin for a given duration. 1-hr, 3-hr and 6-hr FFG values are estimated at model runtimes 00, 06, 12 and 18 UTC. It is a function of threshold runoff, and soil moisture deficit. The lower FFG, the higher the occurrences of flash floods.

6-hr FFG product (upper-right) shows shows predominantly 25-40 mm (yellow colour) for areas around Hopa and even 15-25 mm (red colour) for some certain small place on 24.08.2015 at 06 UTC.

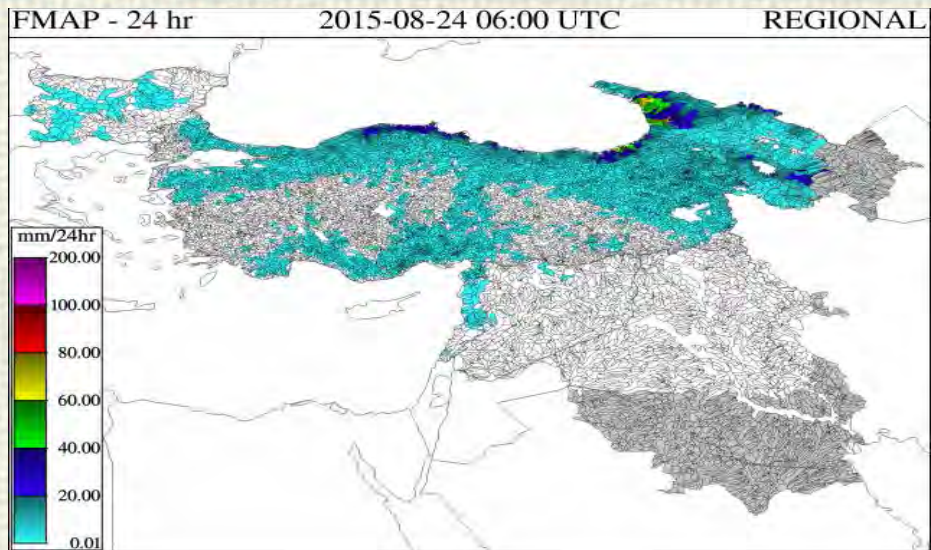
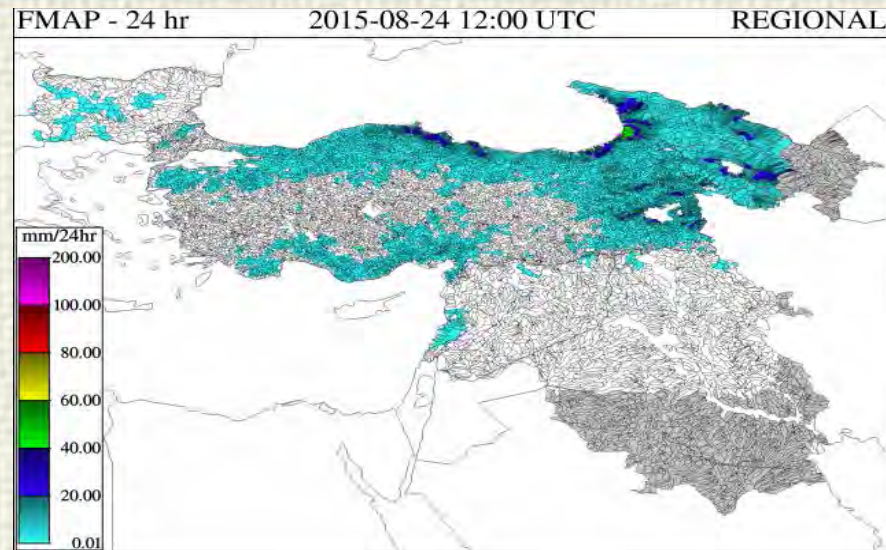
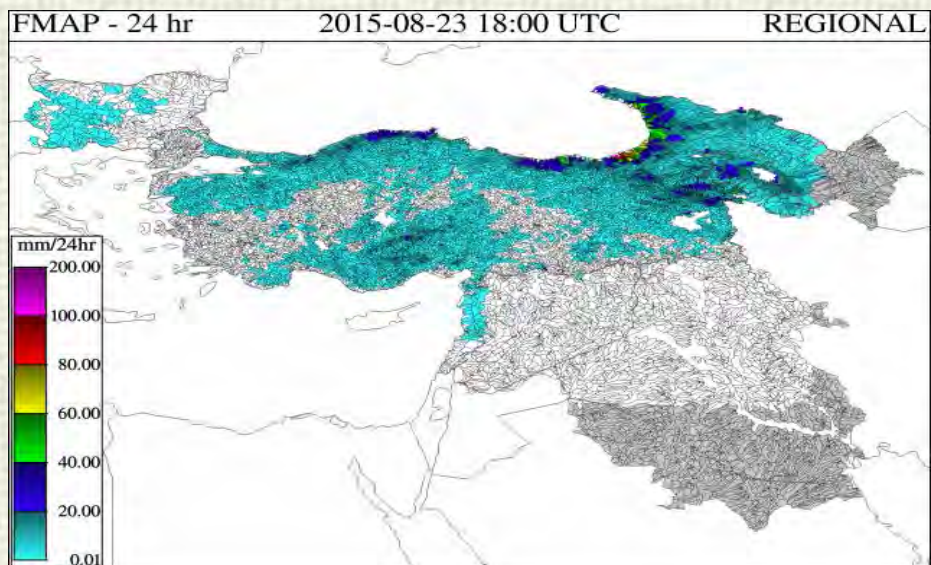
Forecast Mean Areal Precipitation

- FMAP provide 1-hour, 3-hour, 6-hour and 24-hour accumulations of mean areal precipitation (mm) for each sub-basin produced by using numerical forecasts from the Aladin model.
- 24-hour FMAP maps shows possible heavy rainfall around the East Black Sea Coast.
- Especially, it is clearly seen that heavy precipitation area around the East Black Sea Coast is having the maximum values 100-200 mm over the province of the Artvin in the 24-hour FMAP at 18:00 UTC on August 23, 2015. (Bottom-left)

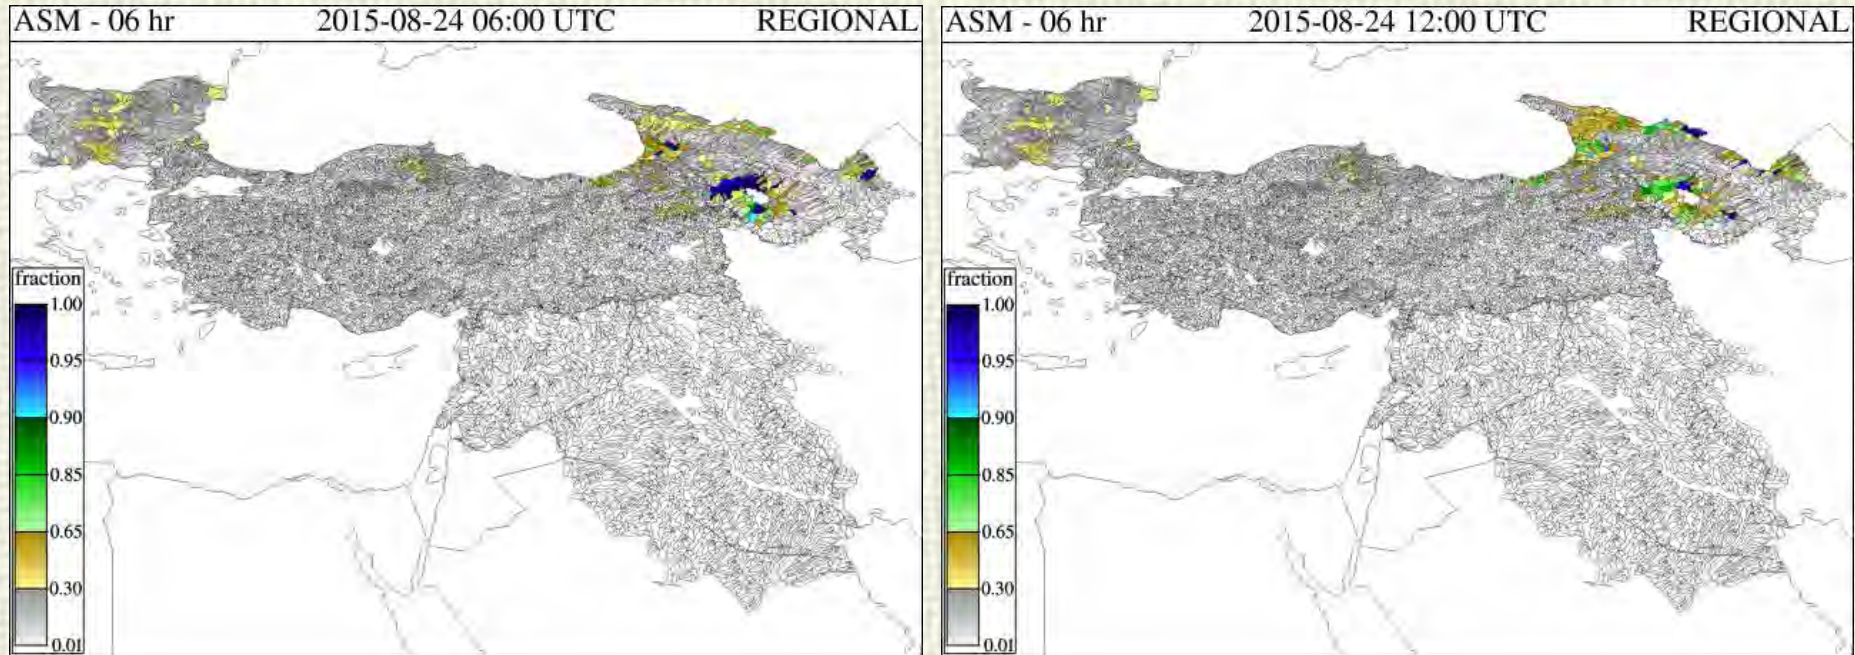
Average Soil Moisture (ASM)

➤ On 24.08.2015 at 06:00 UTC (left) and 12:00 UTC (right), ASM images show that more sub-basin upper soil saturated associated with continues rainfall in the region. Particularly, sub-basins in the province of ARTVİN were remained saturated up to 24 hours making the region very vulnerable to flash flood occurrences.

➤ ASM map shows %90 soil moisture for some sub-basins around the East Black Sea Coast.

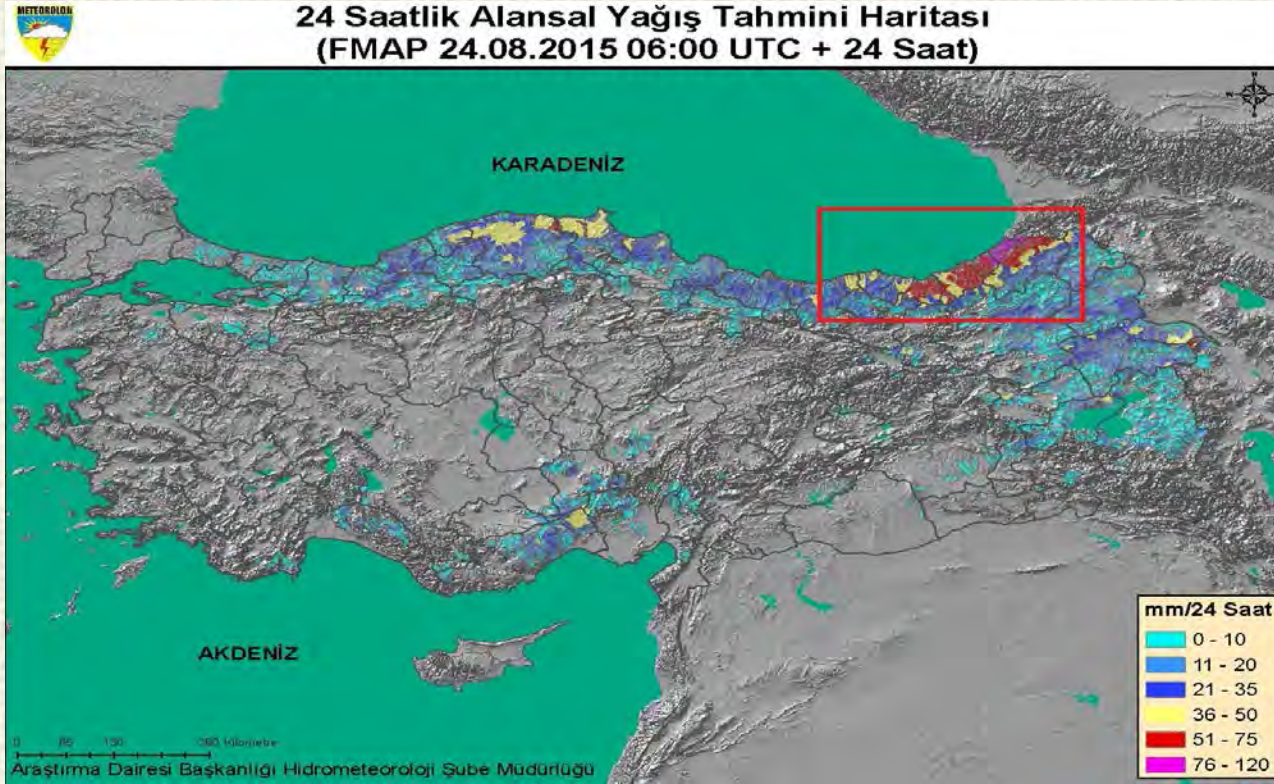
BSMEFFG Flash Flood Bulletin

- Forecast Mean Areal Precipitation Map at 06:00 UTC on August 24, 2015.
- This map is formed by hydrometeorology division of TSMS by using the GIS tools and raw data on the user interface page.
- FMAP shows possible heavy rainfall along the East Black Sea Coast.
- 24-hr FMAP on 24.08.2015 at 06:00 UTC depicts that over the next 24 hours precipitation accumulation changed from 21-35 mm to 120 mm over the East Black Sea Coast.

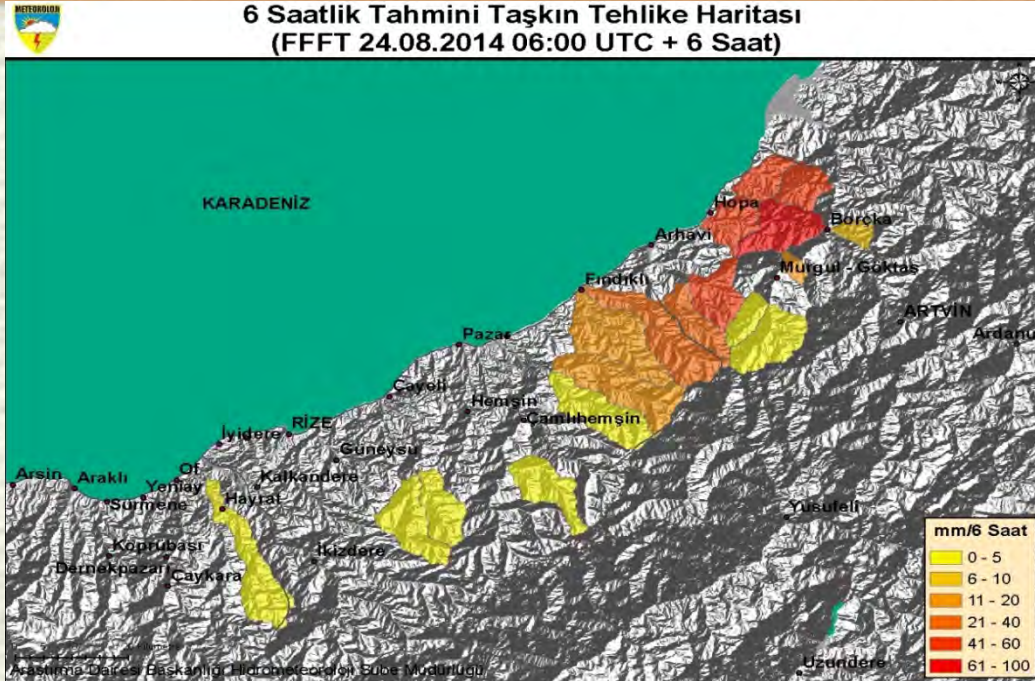
- Forecast Flash Flood Threat (FFFT) Map at 06:00 UTC on August 24, 2015.
- This map provide 6-hour Forecast Flash Flood Threat (mm) for each sub-basin. The values indicate the difference of the FMAP of the given duration and the corresponding current FFG of the same duration.
- FFFT map shows possible heavy rainfall around the East Black Sea Coast especially Hopa, Murgul and Borçka districts of the Artvin.
- 6hr FFFT on 24.08.2015 at 06:00 UTC depicts that over the next 6 hours precipitation accumulation that exceeds the threshold level changed from 5 mm to 100 mm over the East Black Sea Coast.
