Hopa Flash Flood Event

24 August 2015

Yusuf ULUPINAR

Turkish State Meteorological Service
yulupinar@mgm.gov.tr

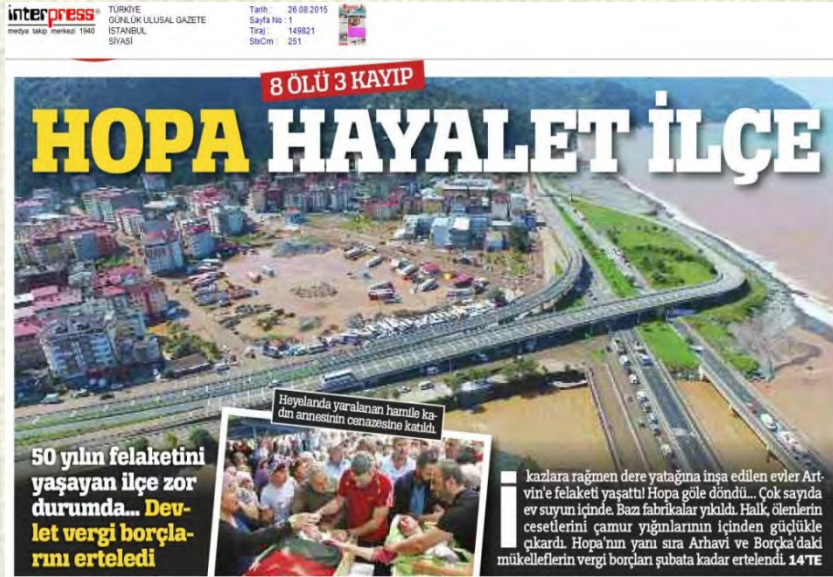
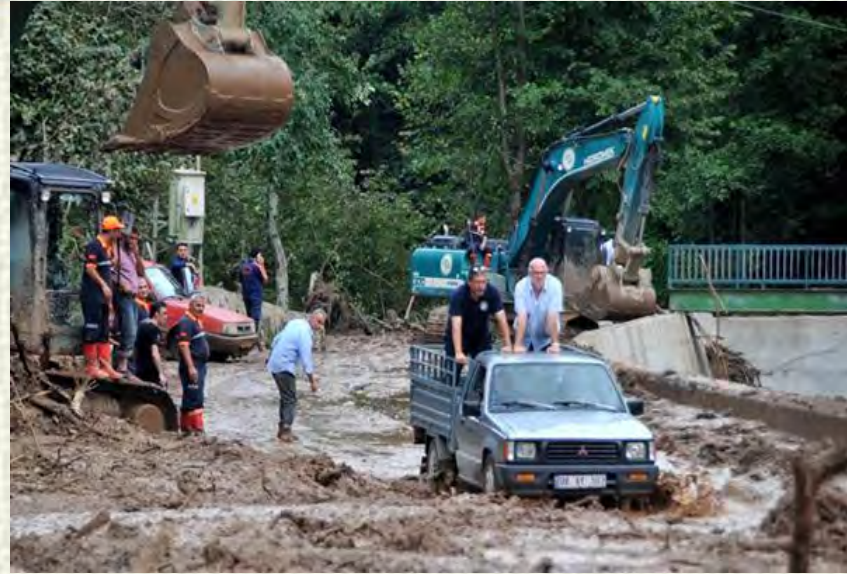
Press Reports

➤ 8 people lost their lives in the flood disaster, three citizens lost and 27 people were injured.

➤ 6 buildings were destroyed. There are 17 heavy and 11 moderately damaged buildings and also evacuation demand was conducted for 24 buildings.

➤ There are 1208 victims in Hopa, 216 in Arhavi and 10 in Borçka.
